MINISTRY OF HOUSING
AND LOCAL GOVERNMENT

REPORT OF THE INQUIRY INTO THE

Collapse of Flats at Ronan Point, Canning Town

Presented to the
Minister of Housing and Local Government by
Mr Hugh Griffiths, QC,
Professor Sir Alfred Pugsley, OBE, FRS, MICE, M I STRUCT E,
Professor Sir Owen Saunders, FRS, HON M I MECH E, F I N S T E

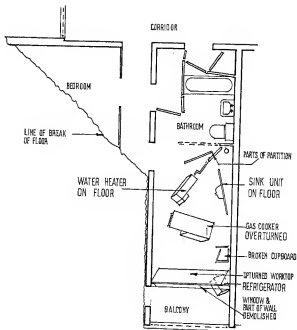
Plan (c) *The extent of the damage to Flat 90*

63. The general nature of the damage and disturbance to the contents of the flat pointed to a region of greatest explosive effect in the hall of the flat near the door of the store cupboard, with a lesser degree of effect in the kitchen and elsewhere. By examining the displacement of articles in the flat and the nature of the damage which they suffered it was possible to trace the pressure wave as it propagated throughout the flat. It was evidence of this nature that finally disposed of a theory put forward during the earlier stages of the inquiry that the explosion had originated within the hall store cupboard. An examination of the damaged hinges of the cupboard door and their screws and also the wood nails attaching the door frame to the wall showed clearly that they had all been bent in a manner which was only consistent with the door being blown inwards into the cupboard and not outwards, as would have been the case had the explosion occurred in the cupboard.

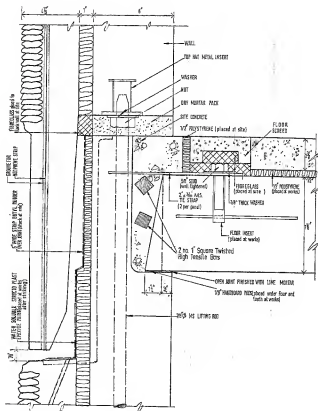
Figure D *Joint H.2. Horizontal joint between floor slab and flank wall*

112. The two cases in which it was found that the workmanship fell below the desired standard were related in some respects to the design of the building. Both concerned the H.2 flank wall joint (Figure D). The first concerned the packing of the dry mortar; it could only be rammed into the $1\frac{1}{2}$ -inch gap from inside the building, and, as the design of the joint did not provide a firm surface against which to ram the mortar, it was thus impossible to ensure that the packing was as good at the outer face of the joint as at the inner. As a result, when we had a portion of such a joint opened up at Ronan Point, it was found that some of the mortar on the outer edge of the packing was loose.

113. The second concerned the tie plates. Figure D shows a metal tie plate fitted over the wall lifting bolt and bolted down at its inner end to the floor slab. The stud used passes through an oval slot in the tie plate and screws into an insert put in the floor slab when it is cast. We had some fifteen of these tie plates inspected at Ronan Point, and in all cases there was evidence of poor workmanship, mainly by way of a failure to tighten the nut of the stud down so as to press the plate against the surface of the floor slab.

114. We found on inquiry that the introduction of these tie plates had a history that was relevant. On a previous contract for a similar type of building in Wandsworth, the District Surveyor there had been dissatisfied with the lack of any mechanical tie between the flank wall panels and the floors, and had insisted upon the introduction of these tie plates in an effort to provide such a tie. In fact, the effectiveness of the tie plates was considerably reduced because the holes through which they were bolted down to the inserts in the floor slabs were oval. This made for ease of assembly but permitted movement at the wall joint before the tie plate could exercise any restraint. Phillips Consultants Limited never appear to have been satisfied about the need for, or value of, these tie plates, and this may have inadvertently engendered a rather careless attitude to the fitting of them.

in doubt that the H.2 joint could withstand a pressure of this order, but estimates of the pressure at which it would ultimately fail varied as widely as from 30 to 850 lb./ft.² (0.21 to 5.91 lb./in.²).

122. We will consider the explosive pressure question first. With the sudden rise of pressure, there is general agreement that at floor level failure probably occurred by a breakdown of the friction between the base of the wall panel and the top of the dry mortar. The only extra opposition to such failure would arise from any restraint provided by the top of the lifting rod, which was probably already under considerable compression. The frictional resistance depends upon the compression load on the joint, which would be somewhat relieved by the bursting action of the gas pressure on the ceiling and floor. In these circumstances, we think that a pressure of about 800 lb./ft.² (5.54 lb./in.²) would have been sufficient to have displaced the wall panel at floor level.

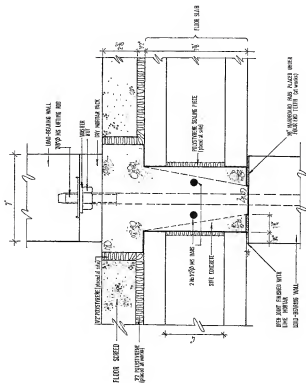
Figure P Joint H.4. Horizontal joint between floor slabs and cross wall

105. The horizontal joints in the load-bearing cross walls at floor level are illustrated by Figure F. The floor slabs have 'nibs' projecting from their ends that rest upon a shelf near the top of the wall panels, and the space between the ends of the opposing floor slabs is filled with in-situ concrete in which two

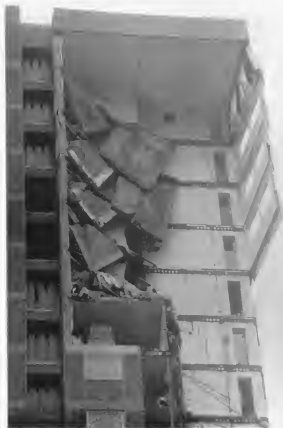
Plate No 2 *Close-up of damage showing wall ' . . . streaming backwards and forwards like a flag . . . '*

48. Mr Raymond Jordan lived in Flat 103 on the north-east corner of the twenty-first floor. After being awakened by a loud noise 'like a thunderbolt', he found that the building was 'rumbling and shaking'. He ran to his balcony and saw pieces of the building and furniture falling. 'There was a big cloud of dust', Mr Jordan said, 'and as I looked up I saw four sections of window frames with the wall still intact all streaming backwards and forwards like a flag . . . ' (See Plate No. 2). These were sections of the eastern wall at the nineteenth, twentieth,

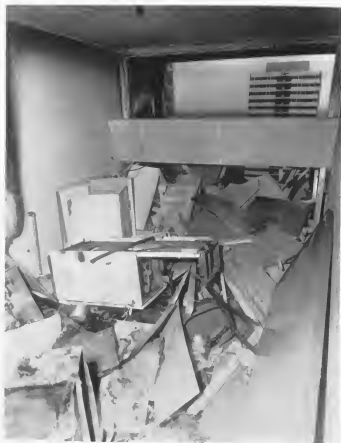
Plate No 7 *Miss Hodge's gas cooker showing the flexible hose*

82. The cooker, however, was found upon its face after the explosion (see Plate No. 7), and the connection between the flexible hose and the standpipe was broken. On further inspection it was discovered that the nut at the standpipe end of the flexible hose was broken. This nut joins the male cone of the connection at the end of the flexible hose to the female connection on the elbow joint at the top of the standpipe. The main body of the nut was still screwed on to the elbow joint union, but the back of the nut had broken away and was found loose on the flexible hose (see Plate No. 8). The wall standpipe was undamaged and showed no degree of deflection.

97. After the explosion the cooker was found lying on its face, and gas was issuing freely from the vertical standpipe in a horizontal direction parallel to the wall, and burning in a flame some 4 feet long. There is no difficulty in accepting that the ignition of this flame was due to the explosion itself. It may be remarked in passing that one hypothesis which was examined and discarded was that there were two explosions, the first one, caused by some fuel other than town gas, which detached the cooker from the standpipe causing a gas leakage, which then produced a second explosion. Since, however, the maximum rate of efflux of gas from the standpipe was about 120 ft.³ an hour, a time interval of the order of half an hour would be essential for sufficient gas to escape into the room to cause an explosion of the order of magnitude of the one which caused the disaster. Since all the observers who gave evidence of two explosions said that the time interval between them was very much shorter than this, we concluded that this hypothesis must be discarded.
