The Texas City Disaster.

A Staff Report.*

Four hundred and sixty-eight persons are known to have lost their lives, over a hundred are still missing (July 1, 1947), and 3000 were injured as the result of fires and ammonium nitrate explosions aboard two ships docked at Texas City, Texas, April 16-17, 1947. Property damage and contingent losses are estimated at \$67,000,000.

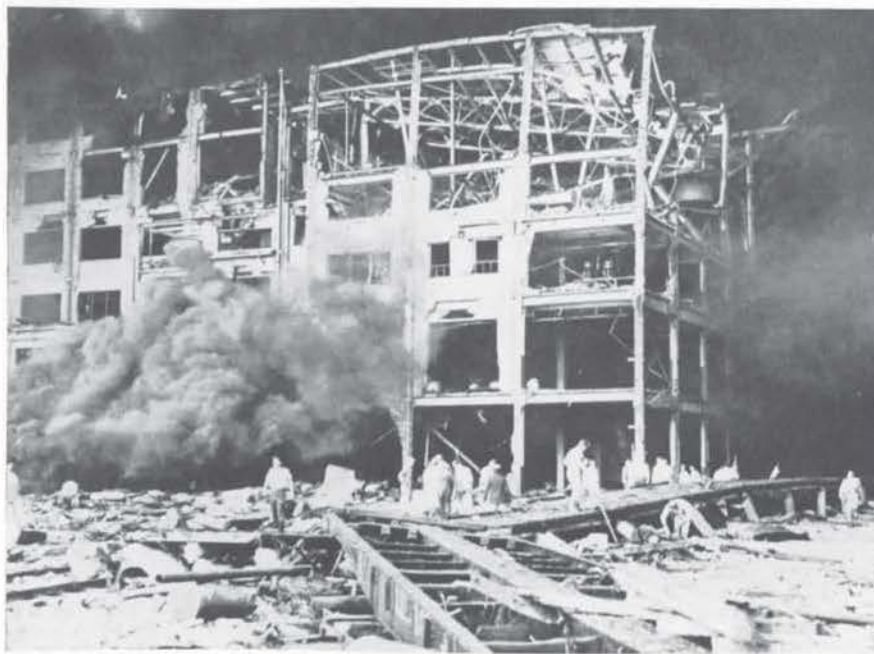
Damage to the five-story polystyrene building of the Monsanto Company while fires were still burning in the area. This building received direct explosion blast from the *Grandcamp* across a distance of only 350 ft.

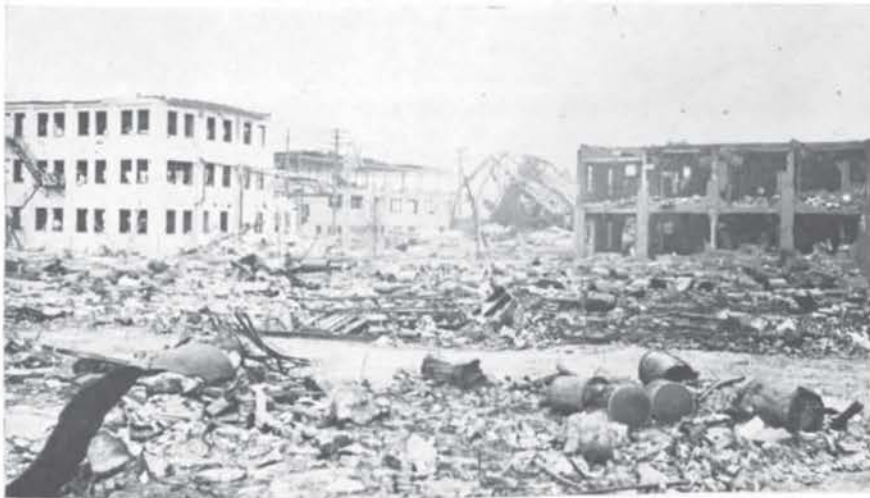
View of Monsanto property, showing wall failures in warehouse at right and damage to office building at left.

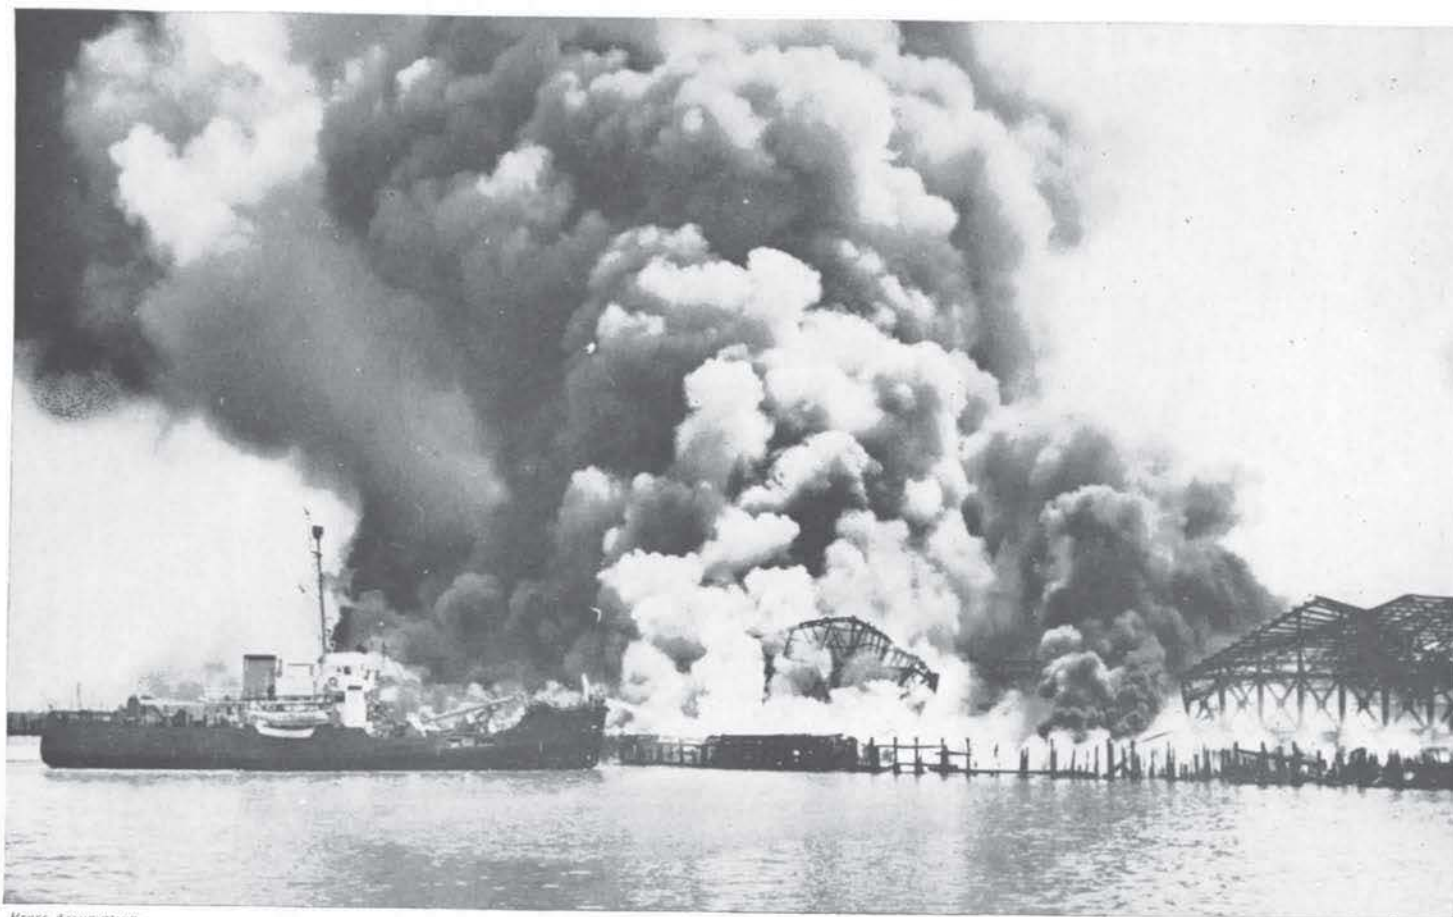
Fires in Warehouses C, D, and E from the Bay side. Docking in front of Warehouses was wood plank on wood piles and supported oil pipe lines used for bulk shipments from this Terminal.

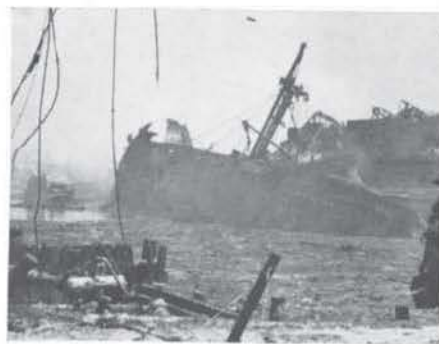
The remains of the *Keene* in the Main Slip. The *High Flyer* exploded as it lay against the *Keene*, having been blown across the slip from Pier "A" by the *Grandcamp* blast.

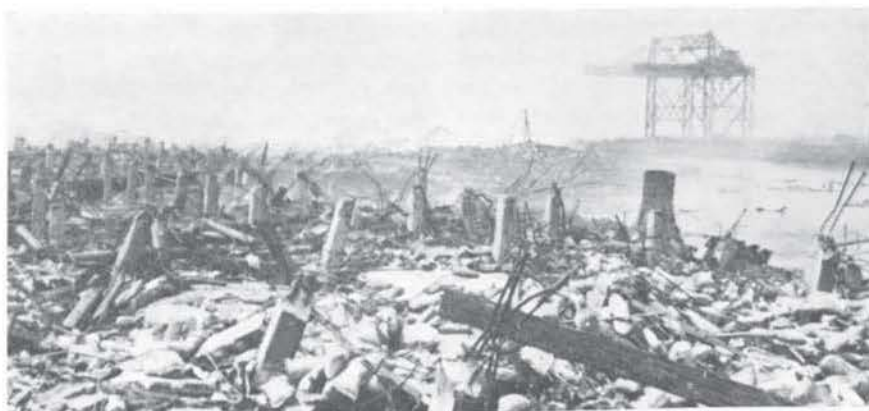
General view of wreckage on Pier A, showing remains of the fire-resistive warehouse. In center, wreckage is former Pier "O," and note that outer end is under water. Seatrain crane marks edge of Monsanto property. The *Grandcamp* was docked in slip next to Pier "O."

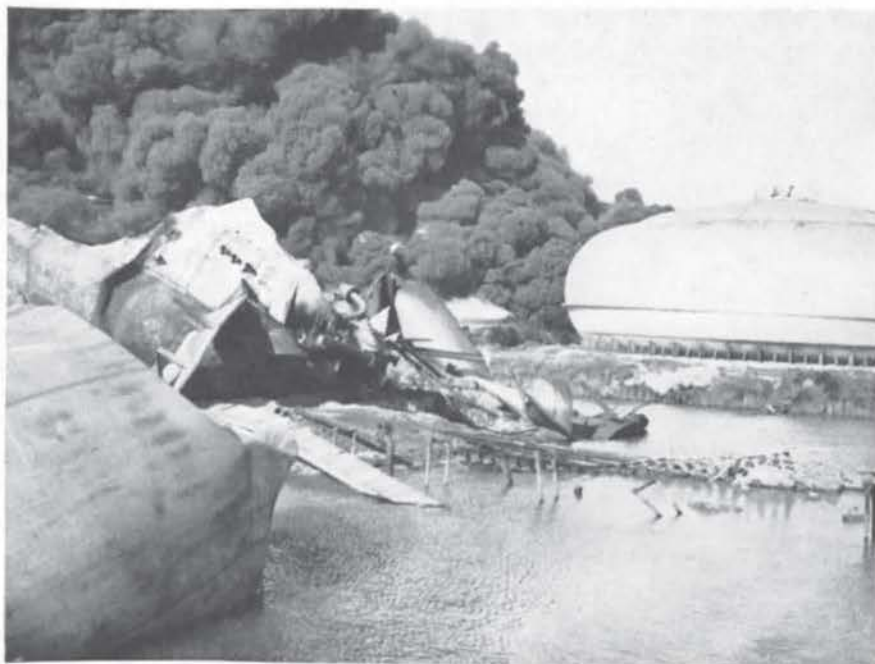
Wreckage in foreground was spheroid, similar to undamaged one at right. Smoke in background from fire on Humble Farm.

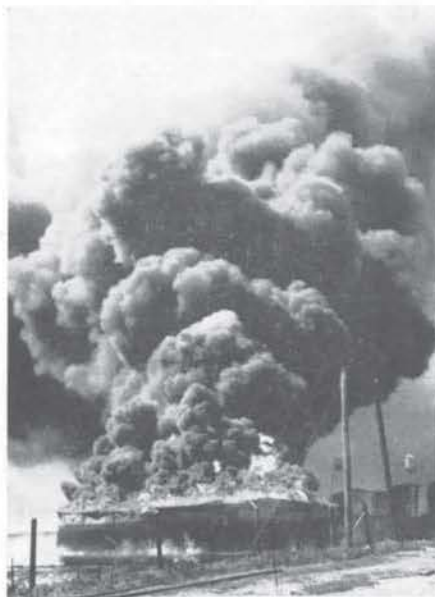
One of the Humble Oil tanks burning two days after the explosion of the *High Flyer*. Ignition attributed to hot missiles.

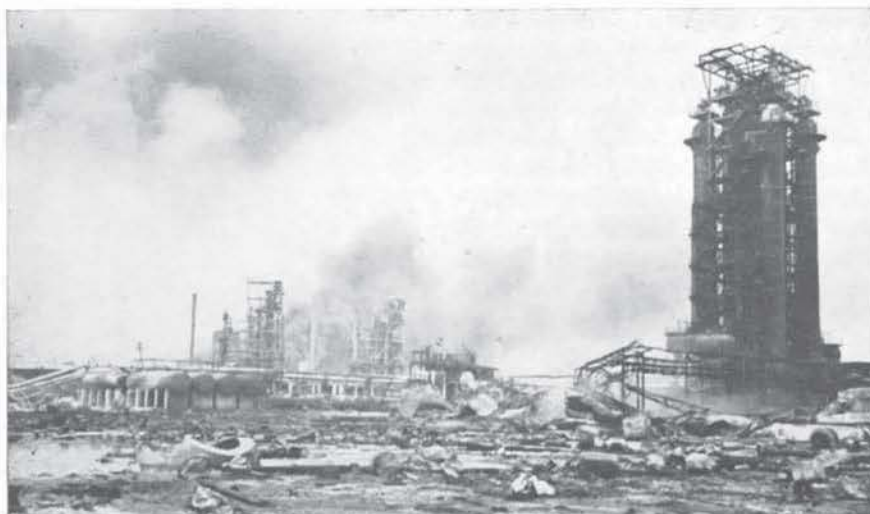
General view of damage in Monsanto plant. One of the 190 ft. distillation towers at right foreground, alkylolation towers at rear, propane tanks in left center, and wreckage of low-pressure hydrocarbon tanks in center foreground.

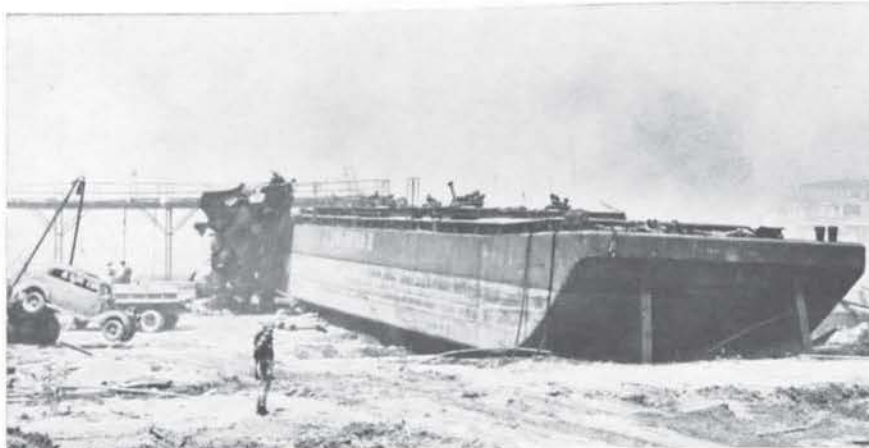
The steel barge which was carried 100 feet inshore by the displaced water in the slip where the *Grandcamp* exploded.

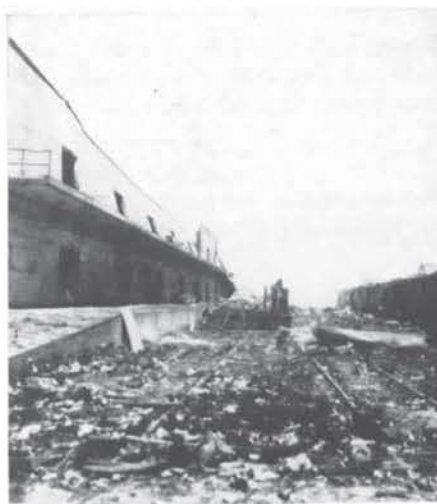
Shows part of fire resistive Warehouse B, which remained upright.

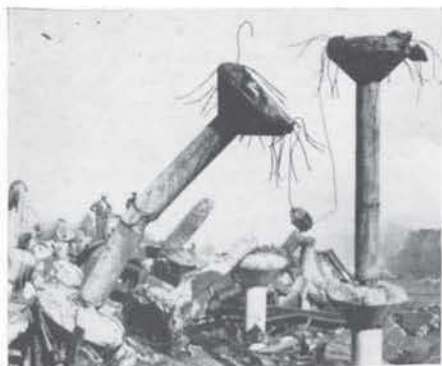
View of reinforced concrete column failure in Warehouse "B."

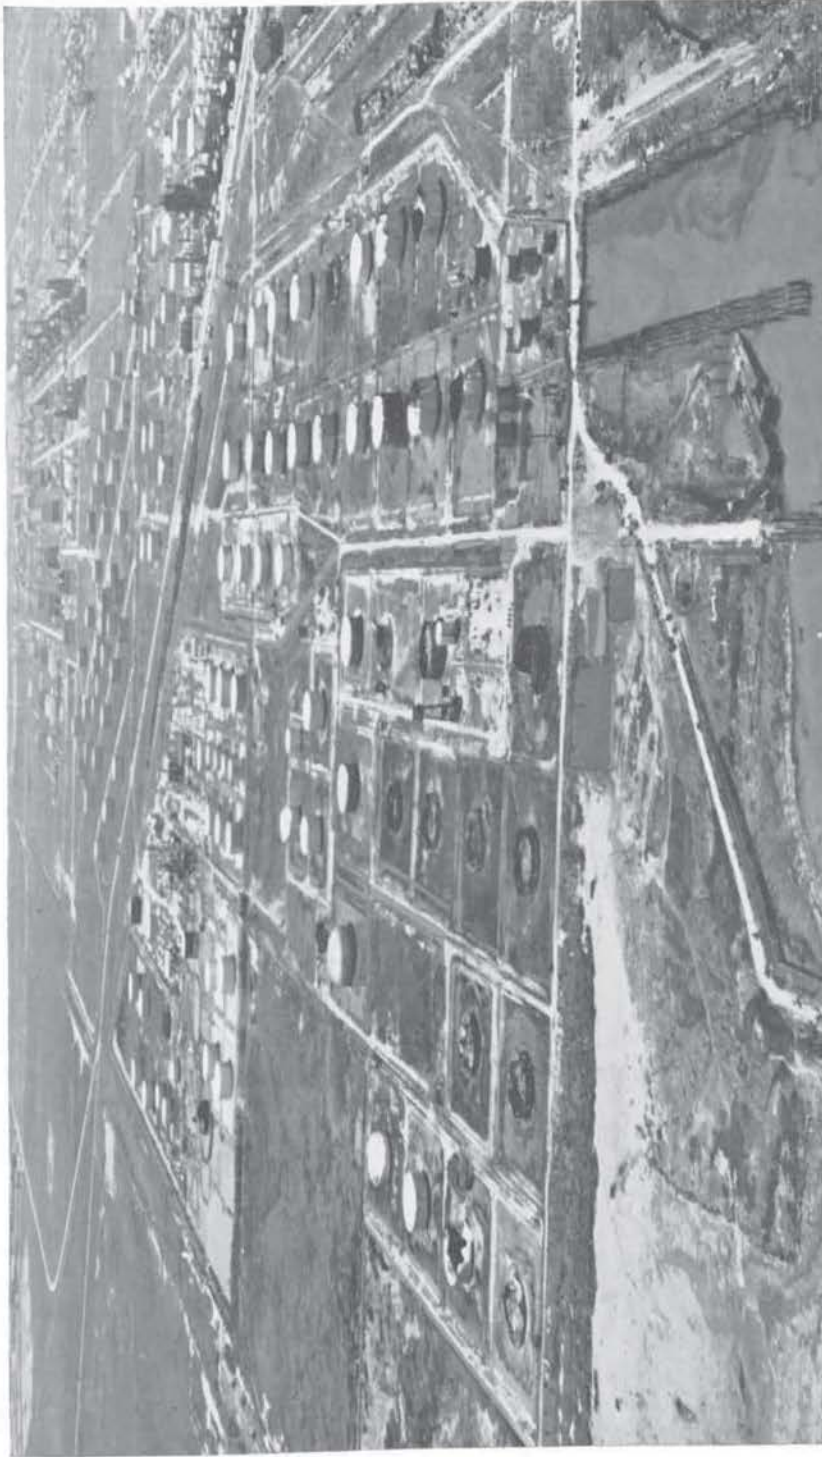
Aerial view of the oil tank farms. Note tanks burned out and those damaged by missiles and concussion. Refinery areas in background. (See other similar photos of Terminal and Monsanto plant.)

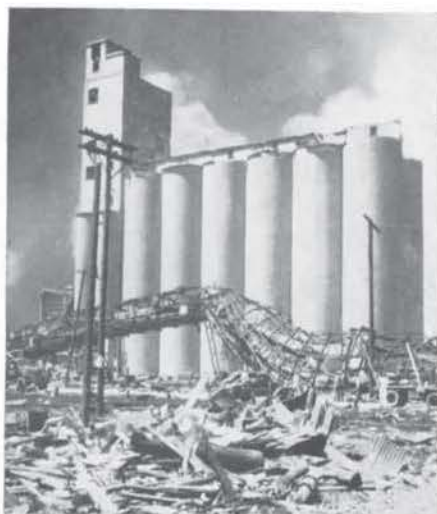
Fire-resistive grain elevator on the Terminal property (damaged more than photo illustrates) and collapsed conveyor.

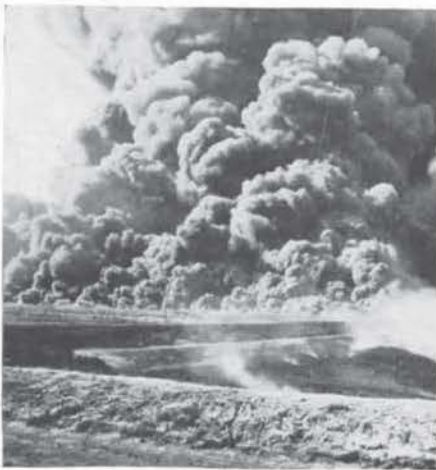
This photo was taken within seconds of a boilover in a crude oil tank in the Humble Tank Farm. This ignited a tank of bunker oil previously not involved.

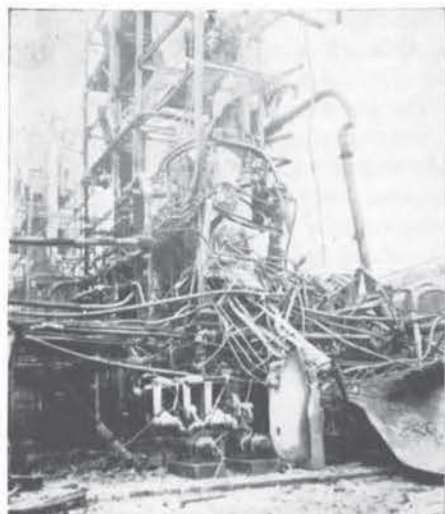
Wreckage of piping at base of ethylene purification fractionation towers in Monsanto plant.

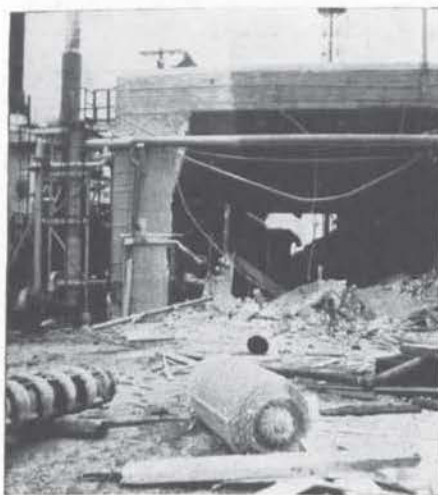
Failure of brick wall in Monsanto Pump House.

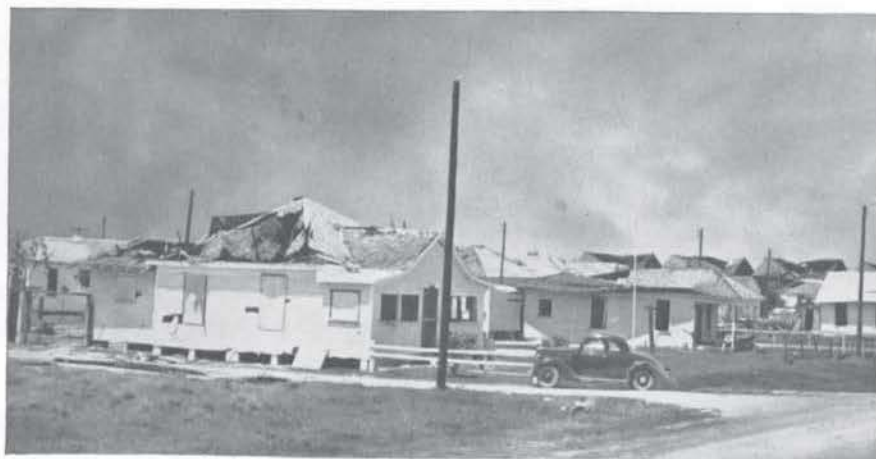
Damage to dwellings in the residential area of Texas City over a mile from the explosions.

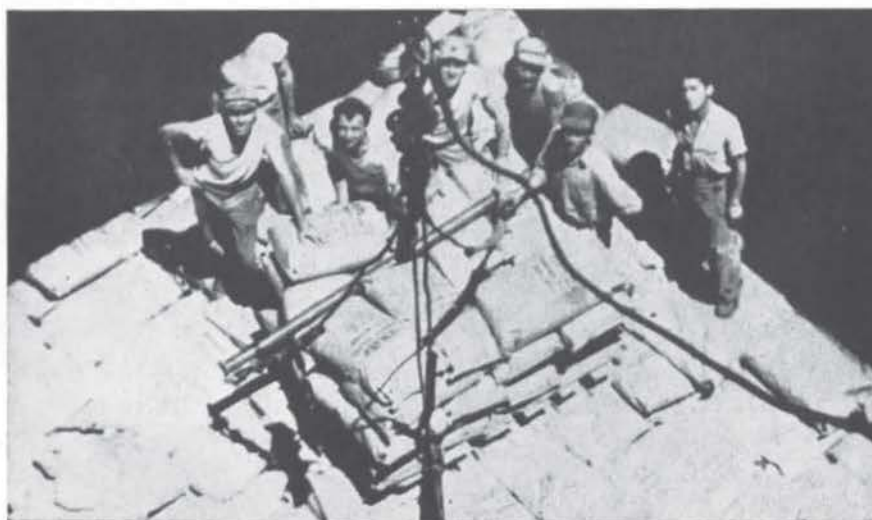
Showing method of loading ammonium nitrate fertilizer aboard ship. Note 100 lb. paper bags and concentrated piling. Broken bags are visible in original print in left foreground.

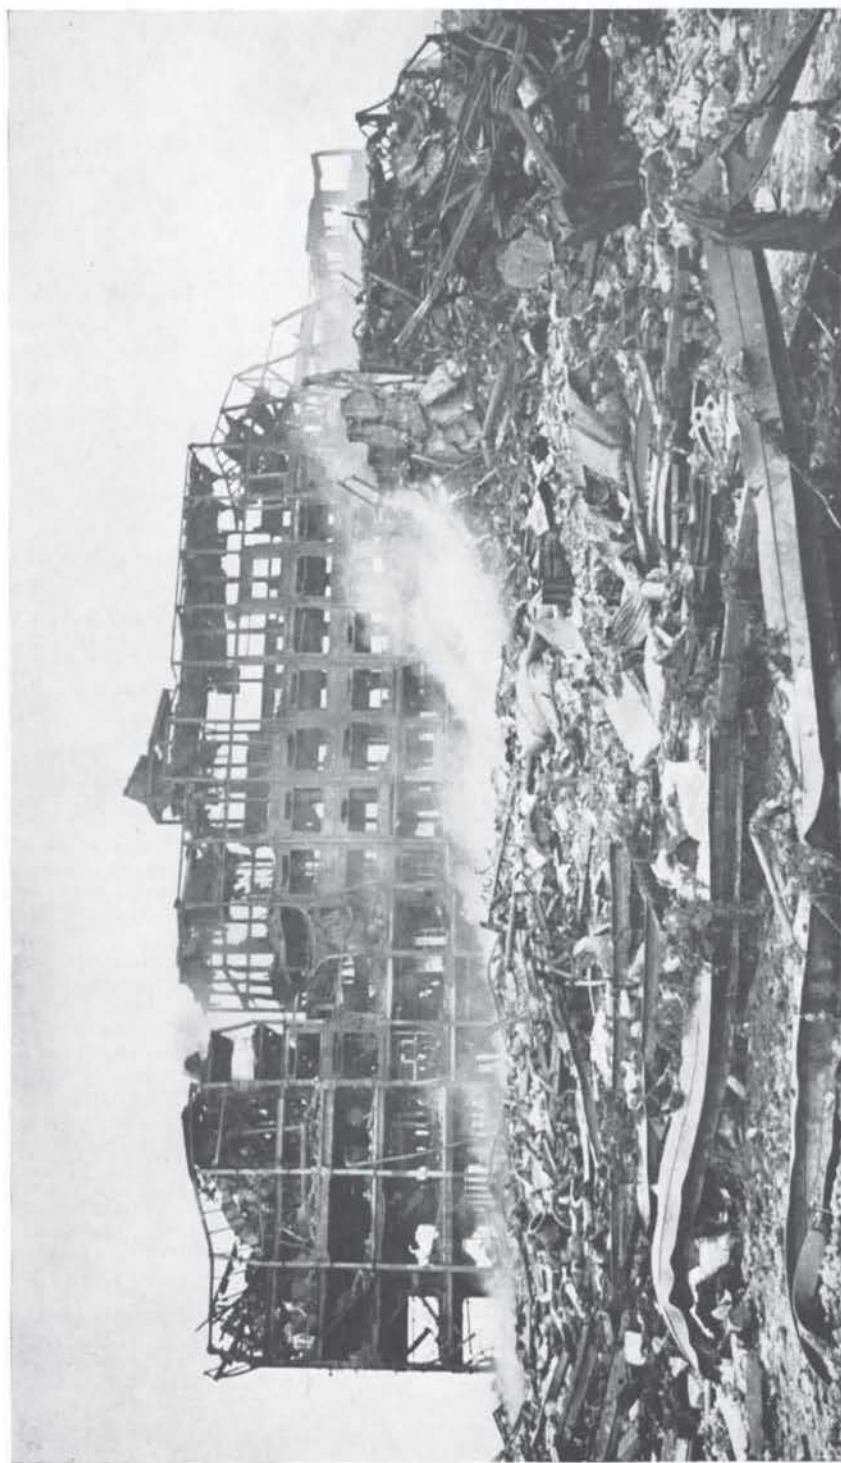
Los Angeles Fire Dept.—Capt. Conline.
Wreckage in foreground is former one-story warehouse of the Monsanto Chemical Company, in left center, the former steam plant and power house, and in background, the polystyrene building.
