REPORT OF INVESTIGATIONS

REPORT ON THE INVESTIGATION OF THE FIRE AT THE LIQUEFACTION,
STORAGE, AND REGASIFICATION PLANT OF THE EAST OHIO
GAS CO., CLEVELAND, OHIO, OCTOBER 20, 1944

At approximately 2:40 p.m. on October 20, 1944, a disastrous fire occurred at the Liquefaction, Storage, and Regasification (LS&R) Plant of the East Ohio Gas Co., Cleveland, Ohio, as the result of failure of an insulated cylindrical tank in which liquefied natural gas was stored at less than 5 p.s.i. pressure and at a temperature of -250°F . Eye witnesses of the initial stages of the failure of the tank reported that streams of liquid or fog issued from its side, and that almost immediately the tank opened and discharged its entire contents of liquefied natural gas over the plant area and adjoining property at a lower elevation. The gas or vapor was ignited almost immediately after failure of the tank. Liquefied gas entered storm sewers, mixed with air, was ignited, and exploded. The explosions damaged the sewer system and the paving of some of the streets. The intense fire in the vicinity of the plant caused great loss of life and property. Final tabulation of fatalities by the coroner's office indicat

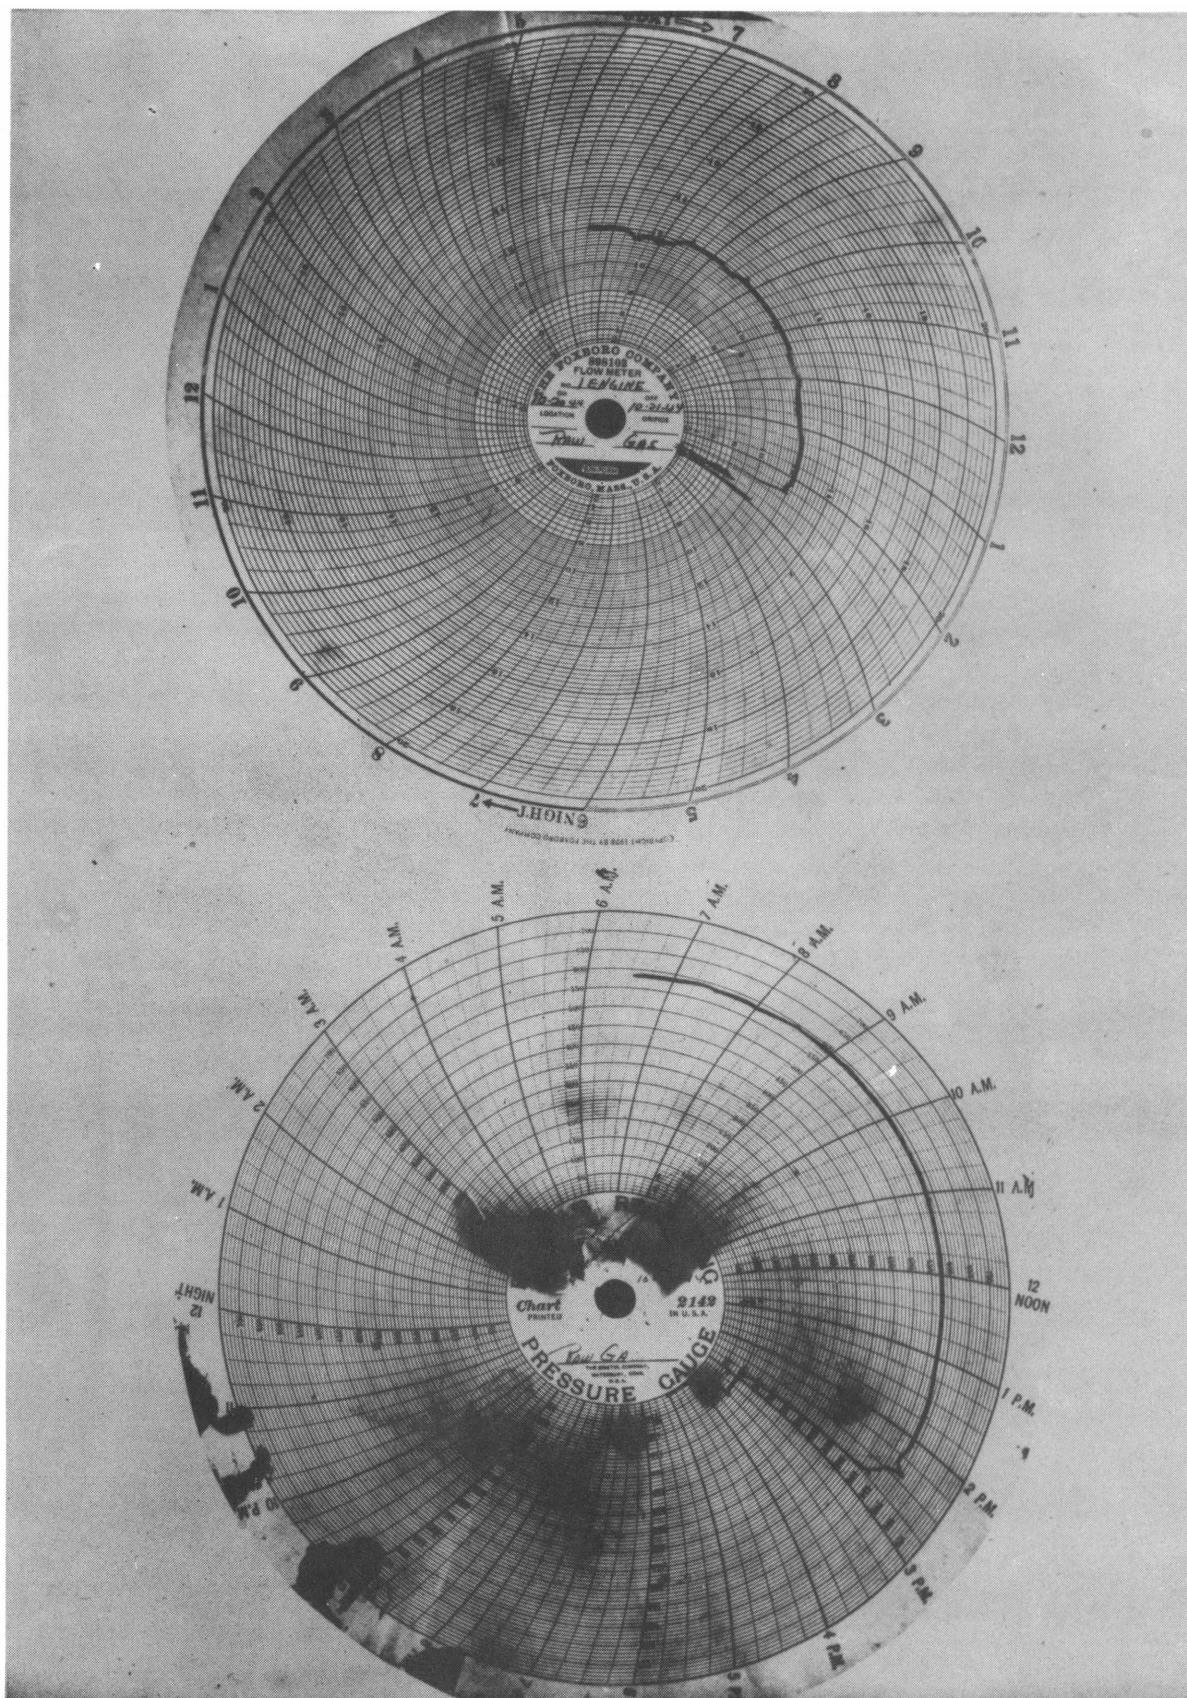
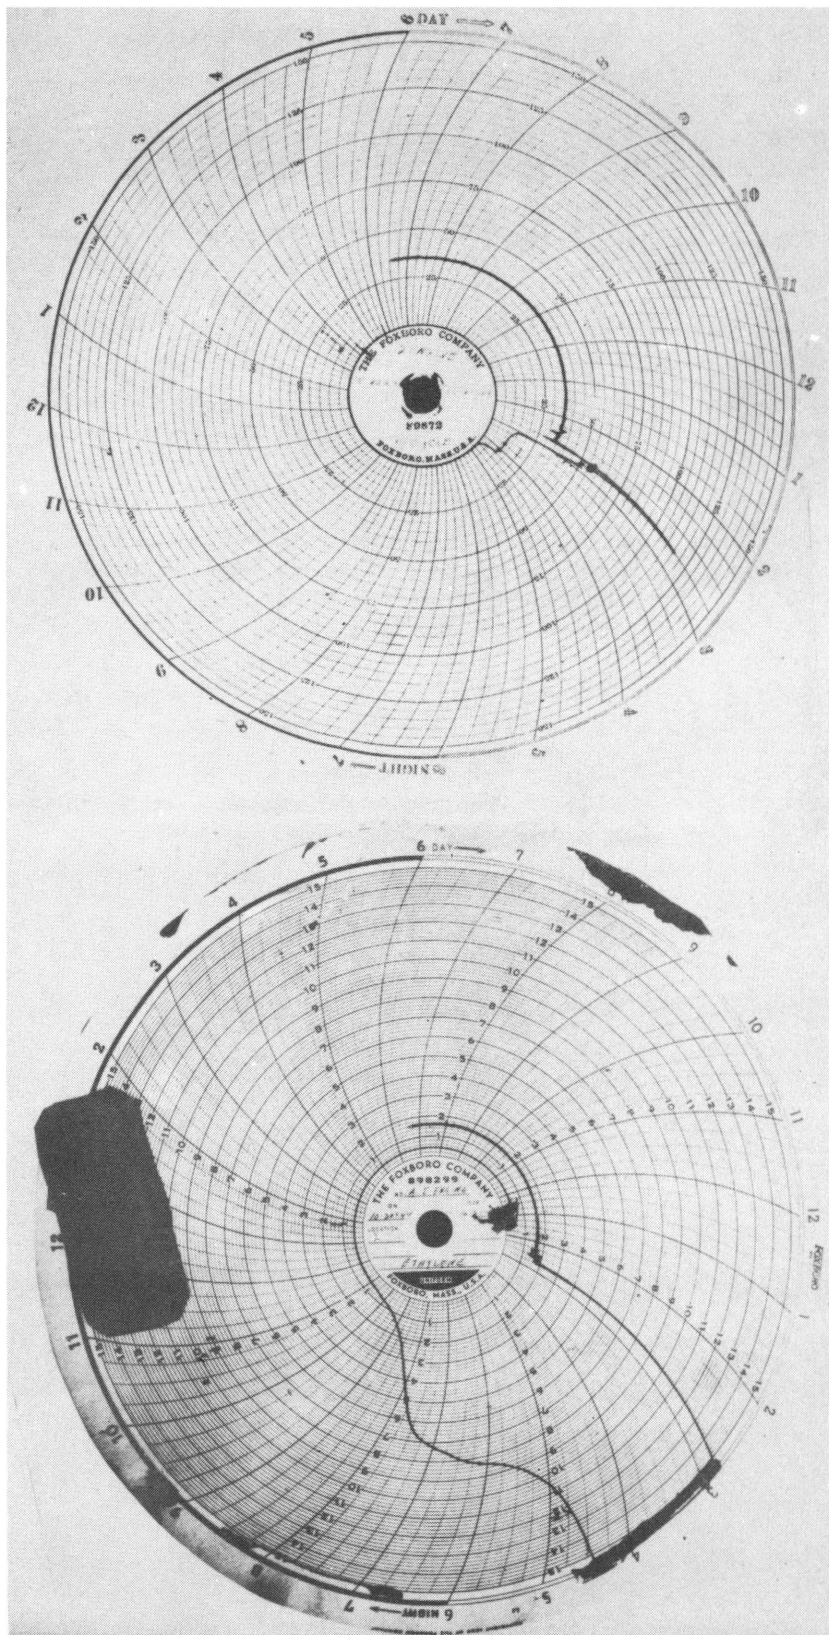
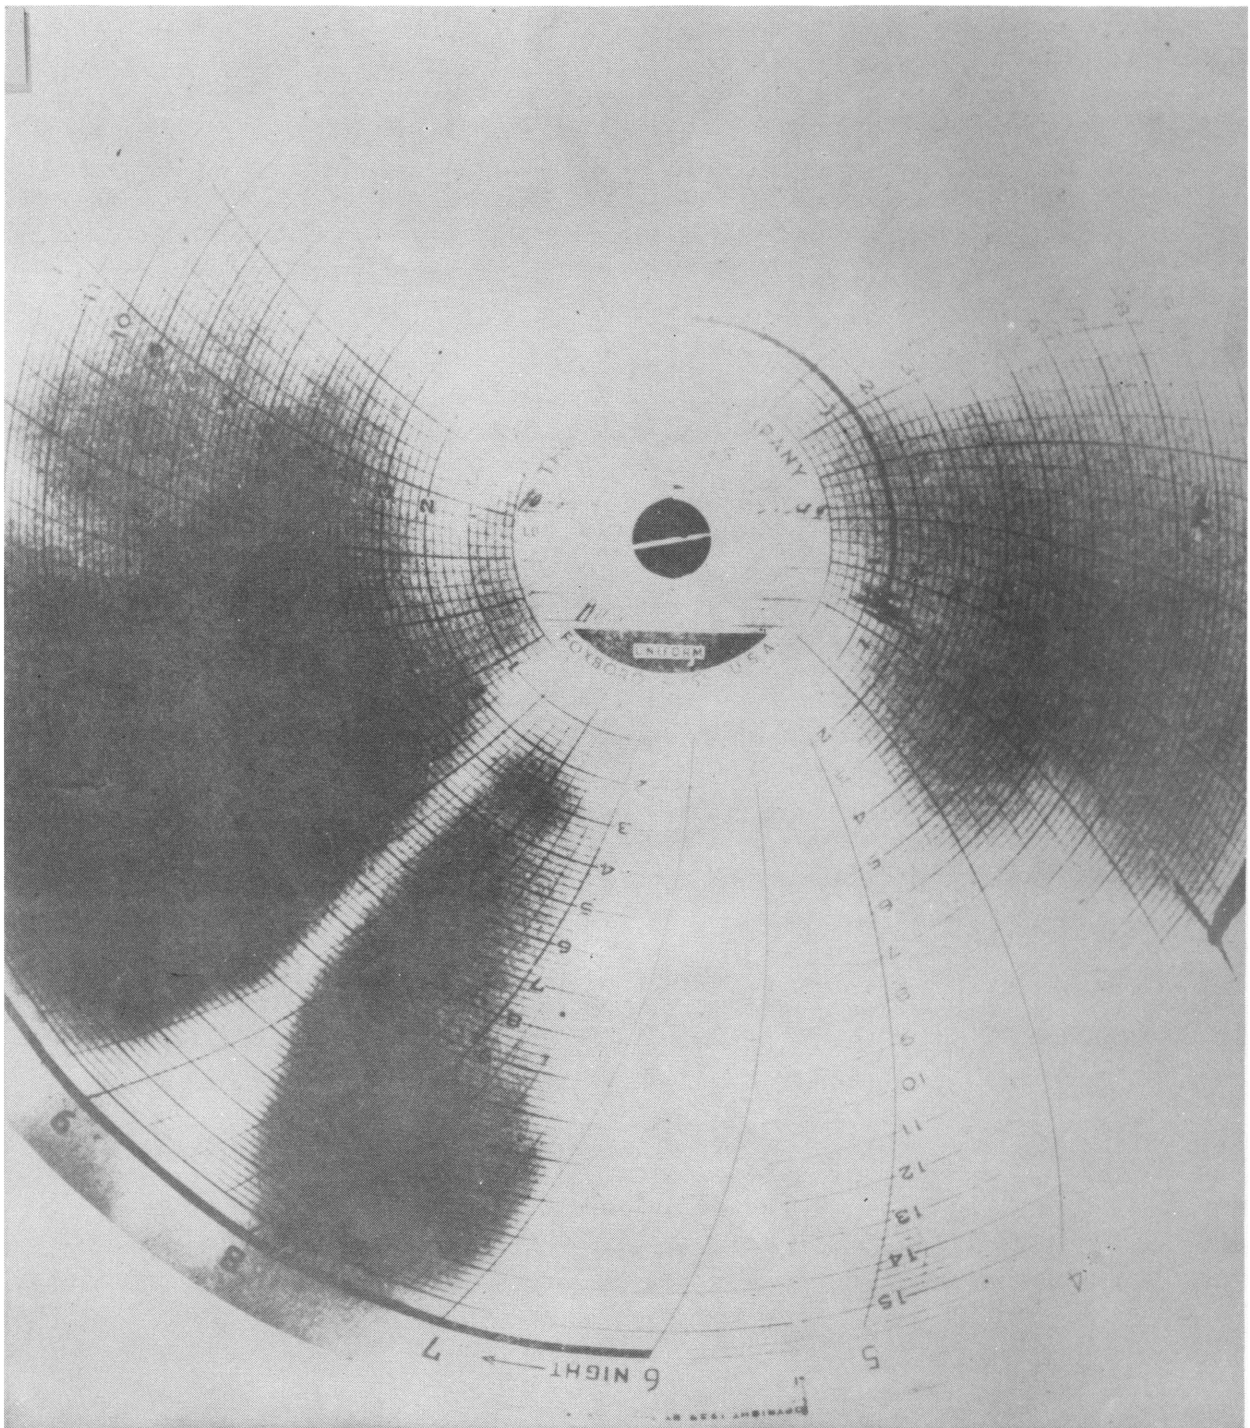
Inspection of the charts reproduced in figures 17, 18, and 19 shows a rapid increase in the pressure in the suction line to No. 2 recycle compressor (No. 3 engine) at 2:45 p.m., the ethylene compressors (Nos. 4 and 5 engines), and the ammonia compressor (No. 6 engine). According to Feightner, this rapid increase in pressure was caused by a sudden shut-down of the compressors. In all three instances, refrigerated liquids were being vaporized in three separate systems, each connected to the respective suction lines of these compressors. A sudden shut-down of a compressor would therefore cause pressure in the suction line to increase. Feightner stated that, even during normal plant operation, if a compressor shut down because of some difficulty, the pressure in the suction line would increase and relief valves would function.

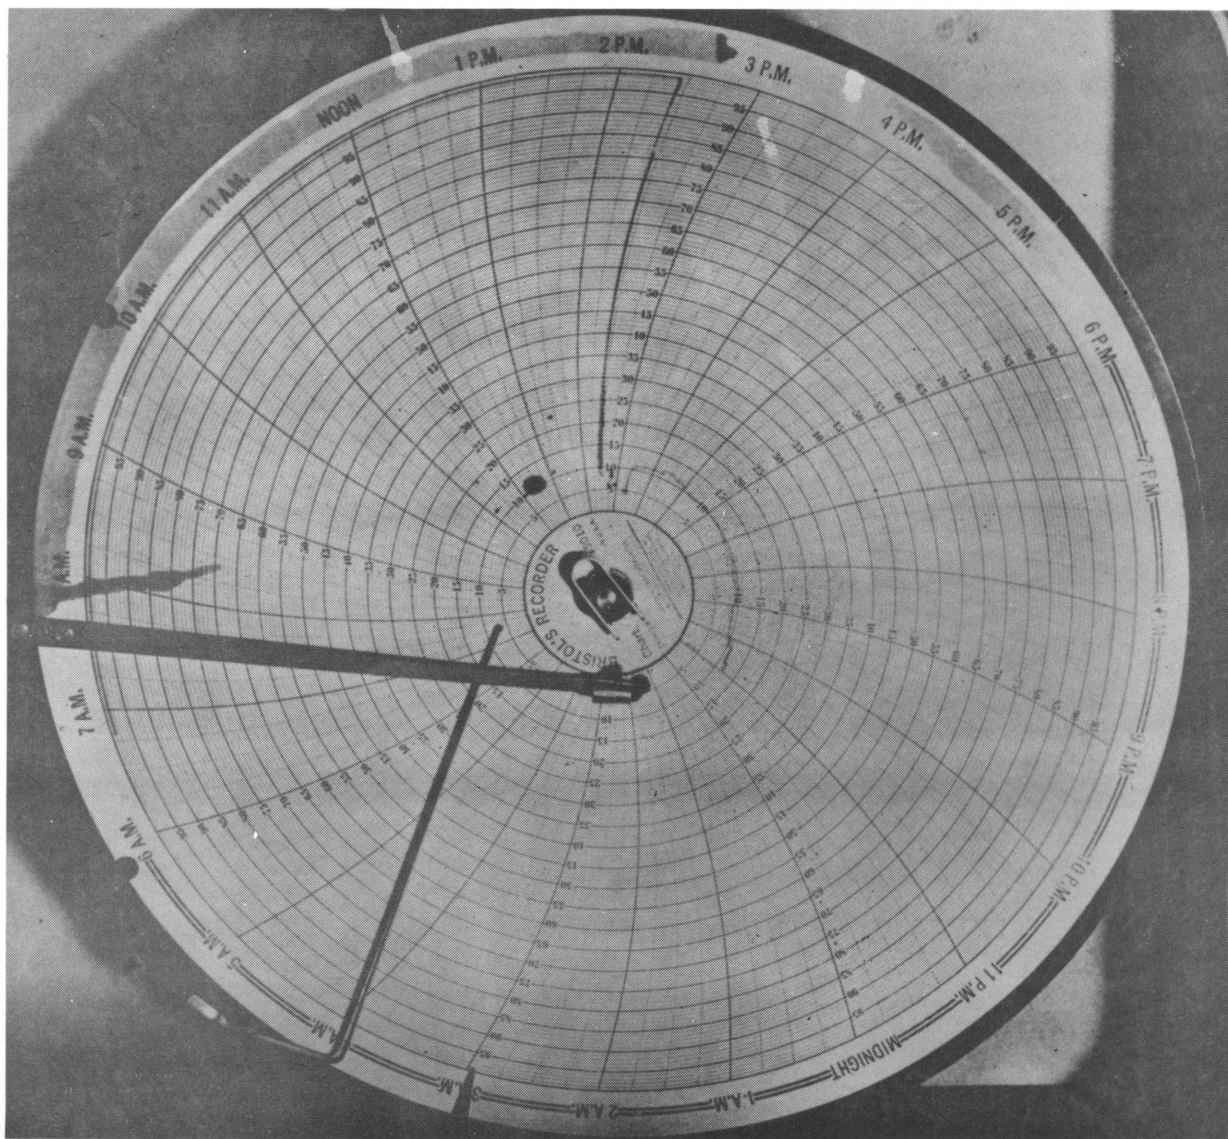
Figure 21.—Photostat of chart showing liquid level in tank 4 on October 20, 1944.

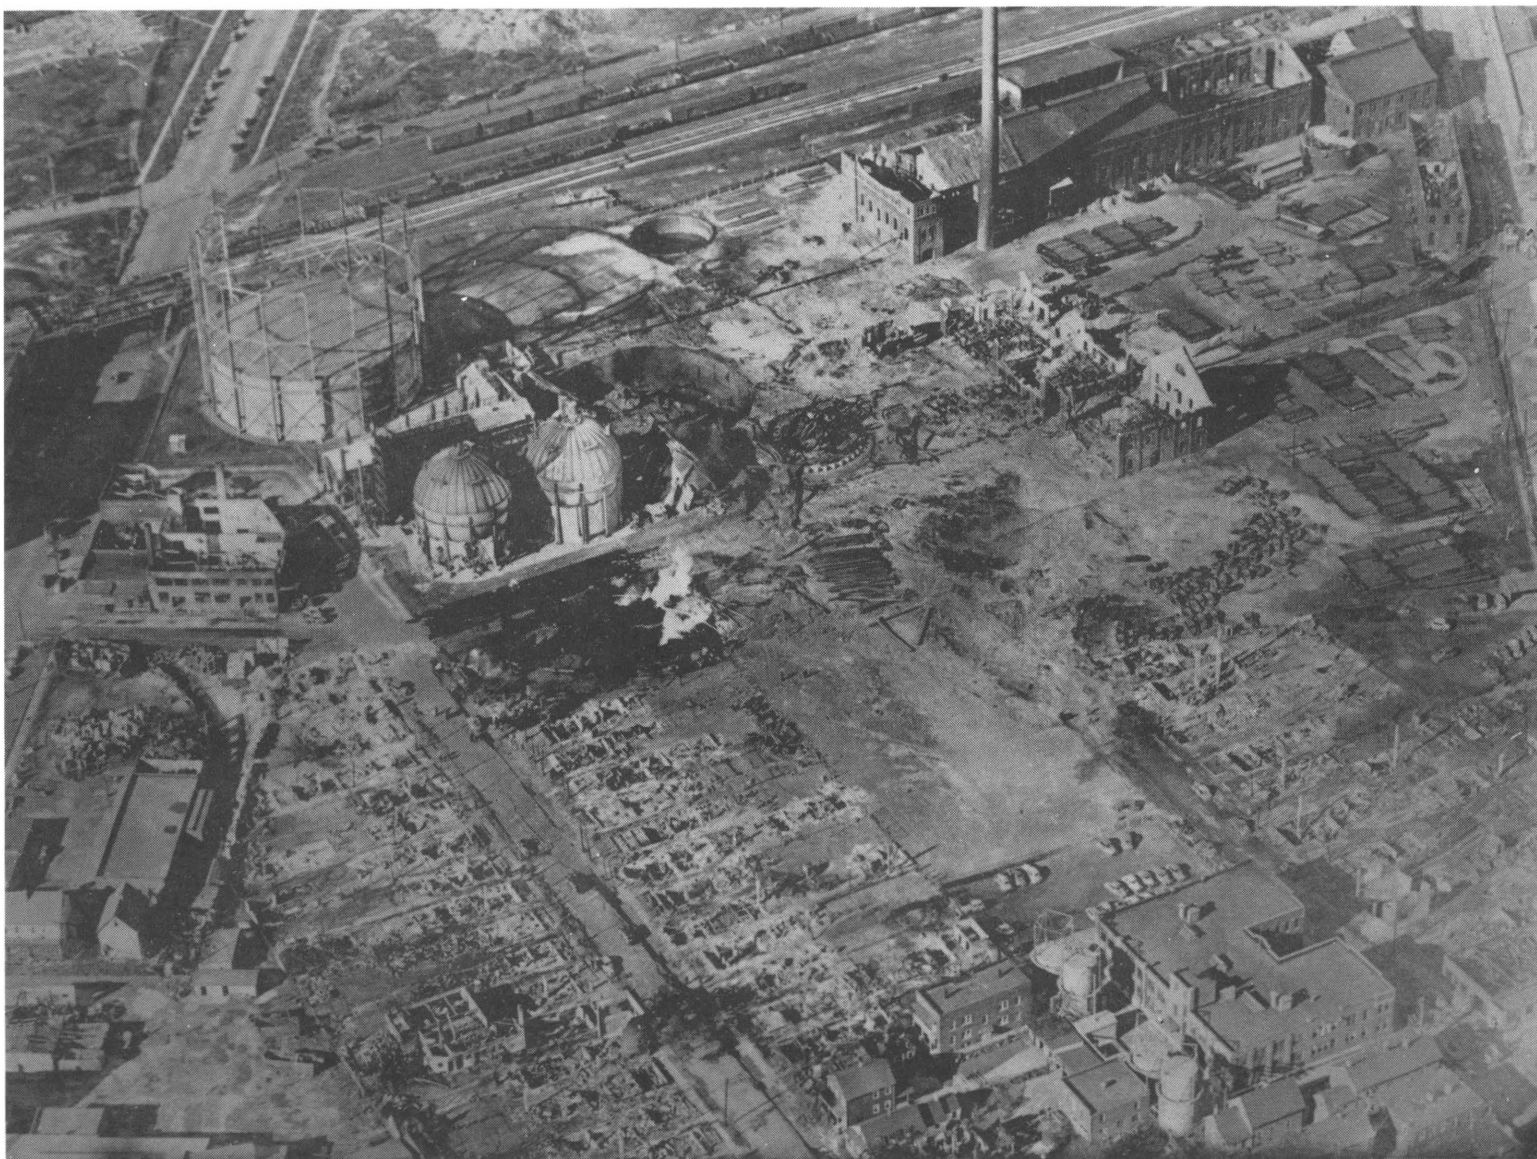
Figure 23.—Aerial view of LS & R plant and No. 2 works, East Ohio Gas Co., and adjoining property damaged by fire October 20, 1944, looking north.

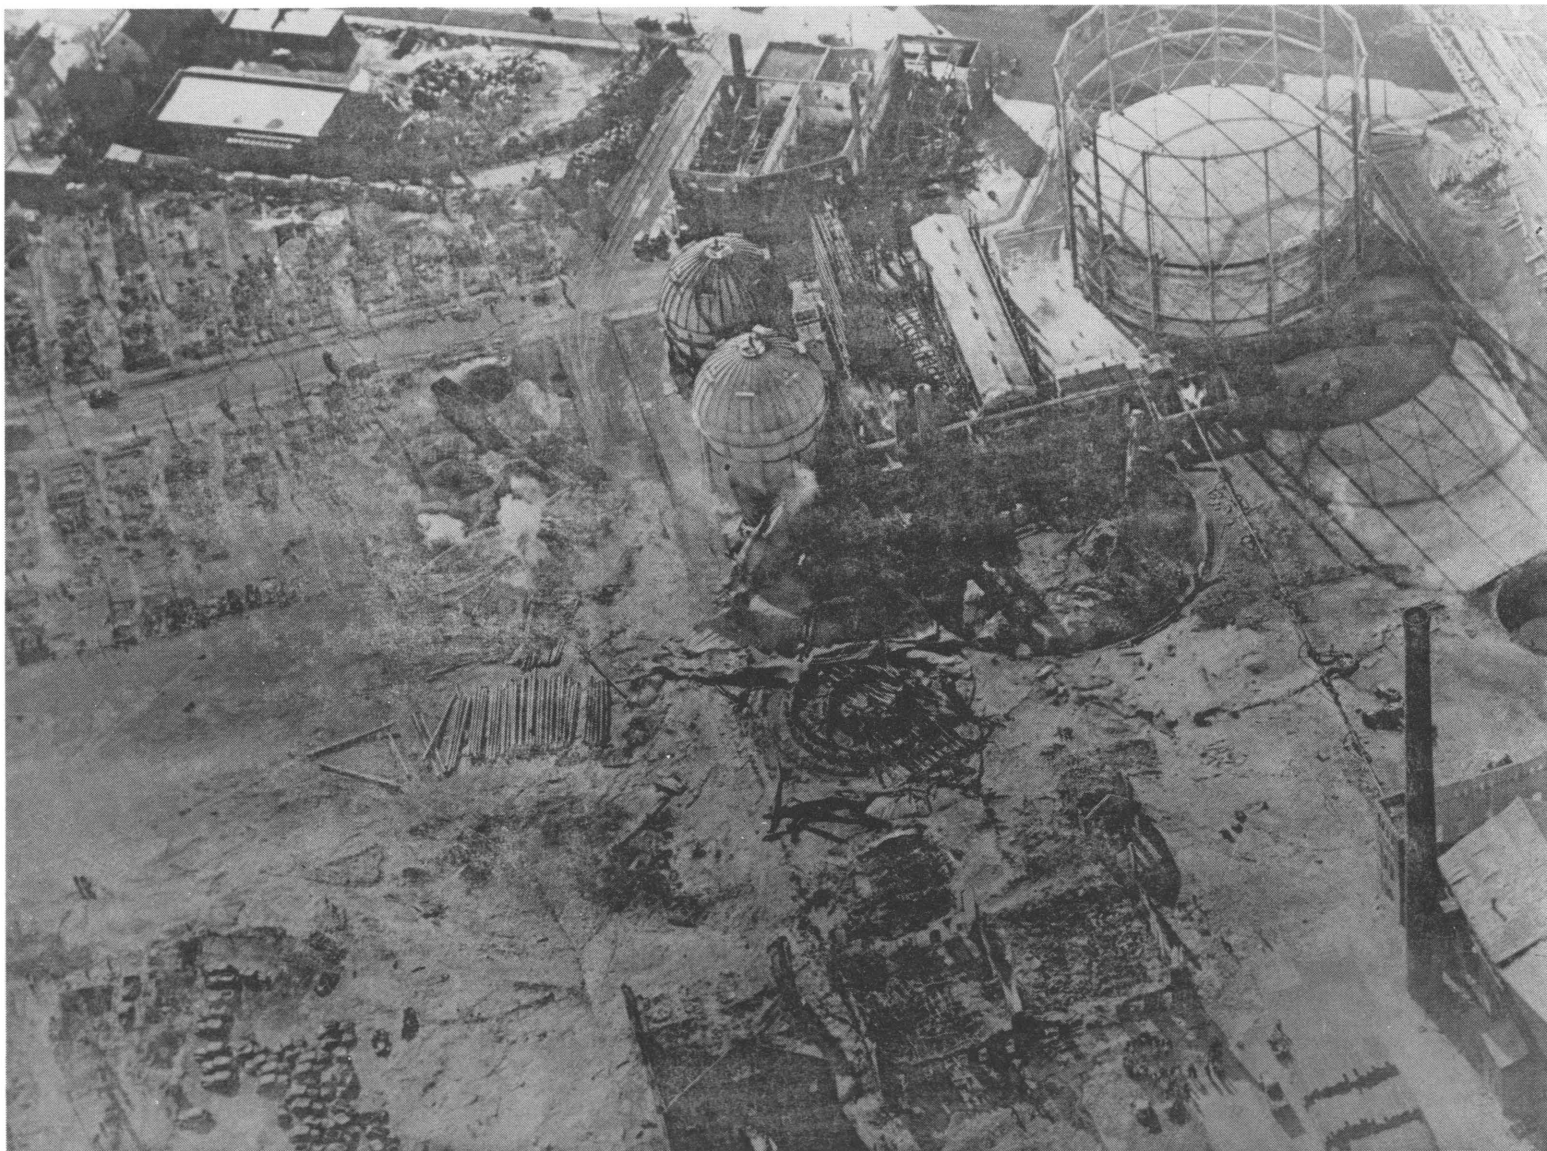
Figure 24.—Aerial view of damaged LS & R plant, East Ohio Gas Co., and a portion of No. 2 works and adjoining property damaged by fire on October 20, 1944, looking southwest.

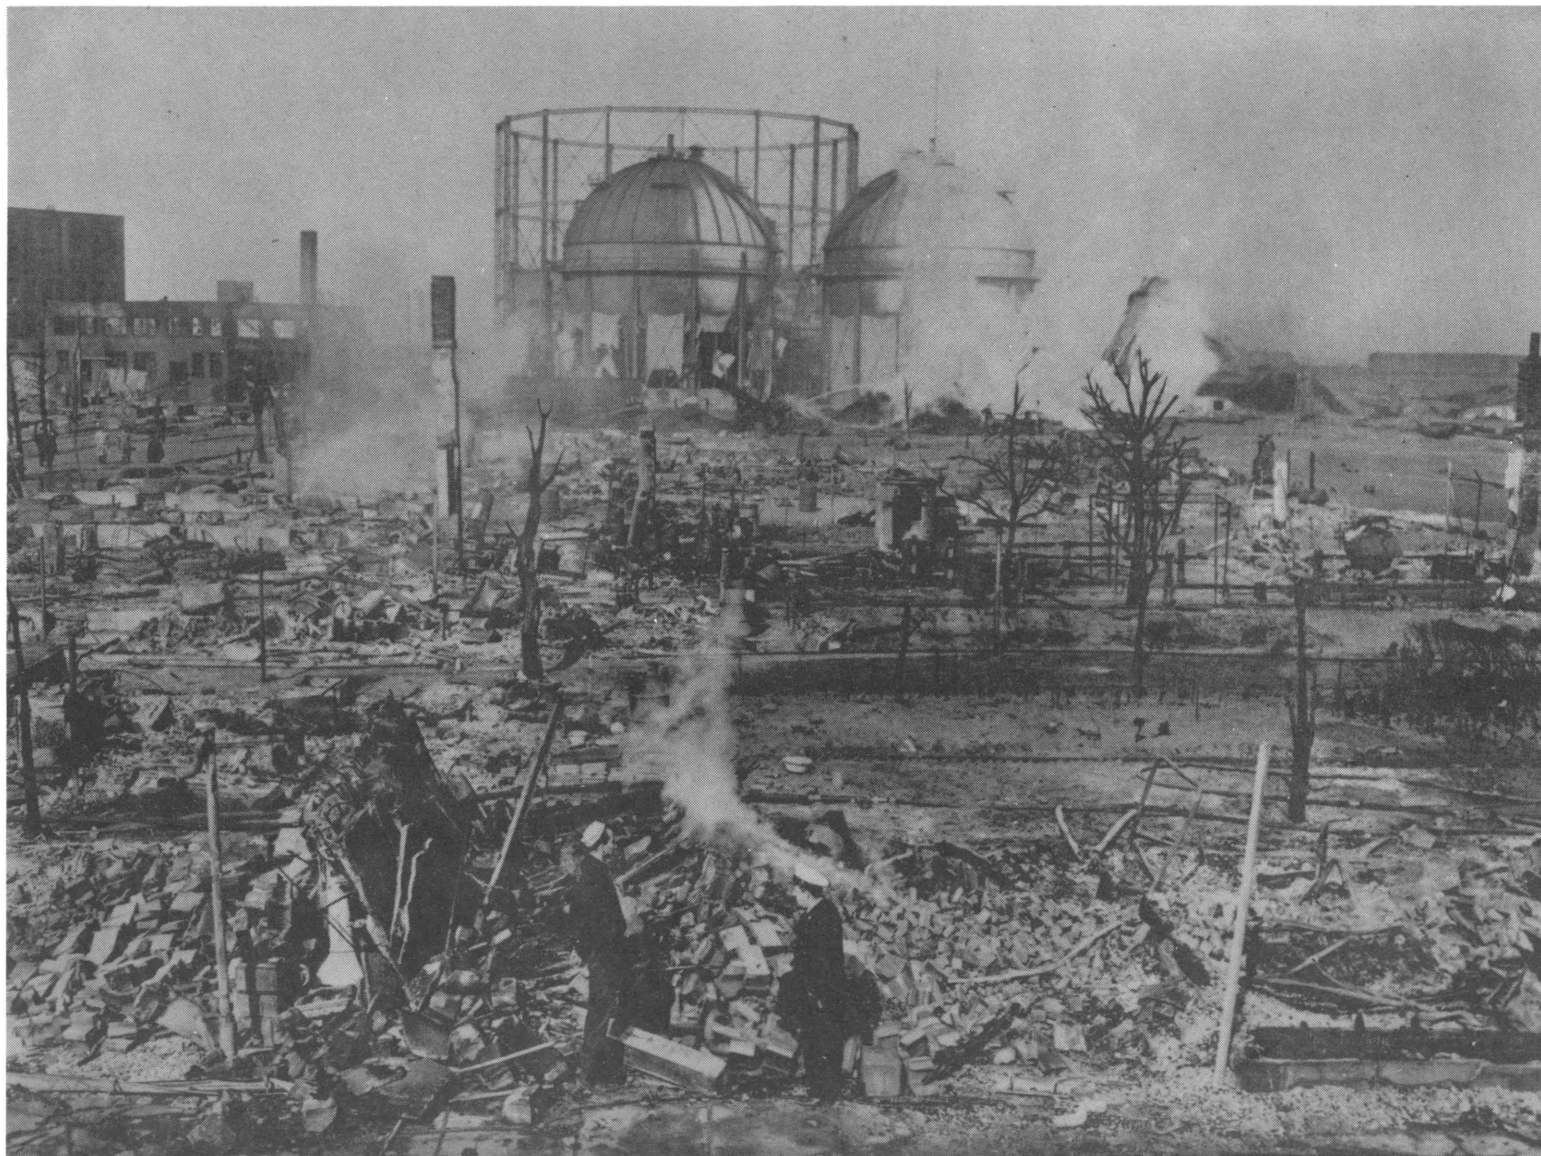
Figure 25.—Damage in the vicinity of the LS & R plant, East Ohio Gas Co., looking toward the northwest and showing remains of dwellings on the east side of East 61st Street.

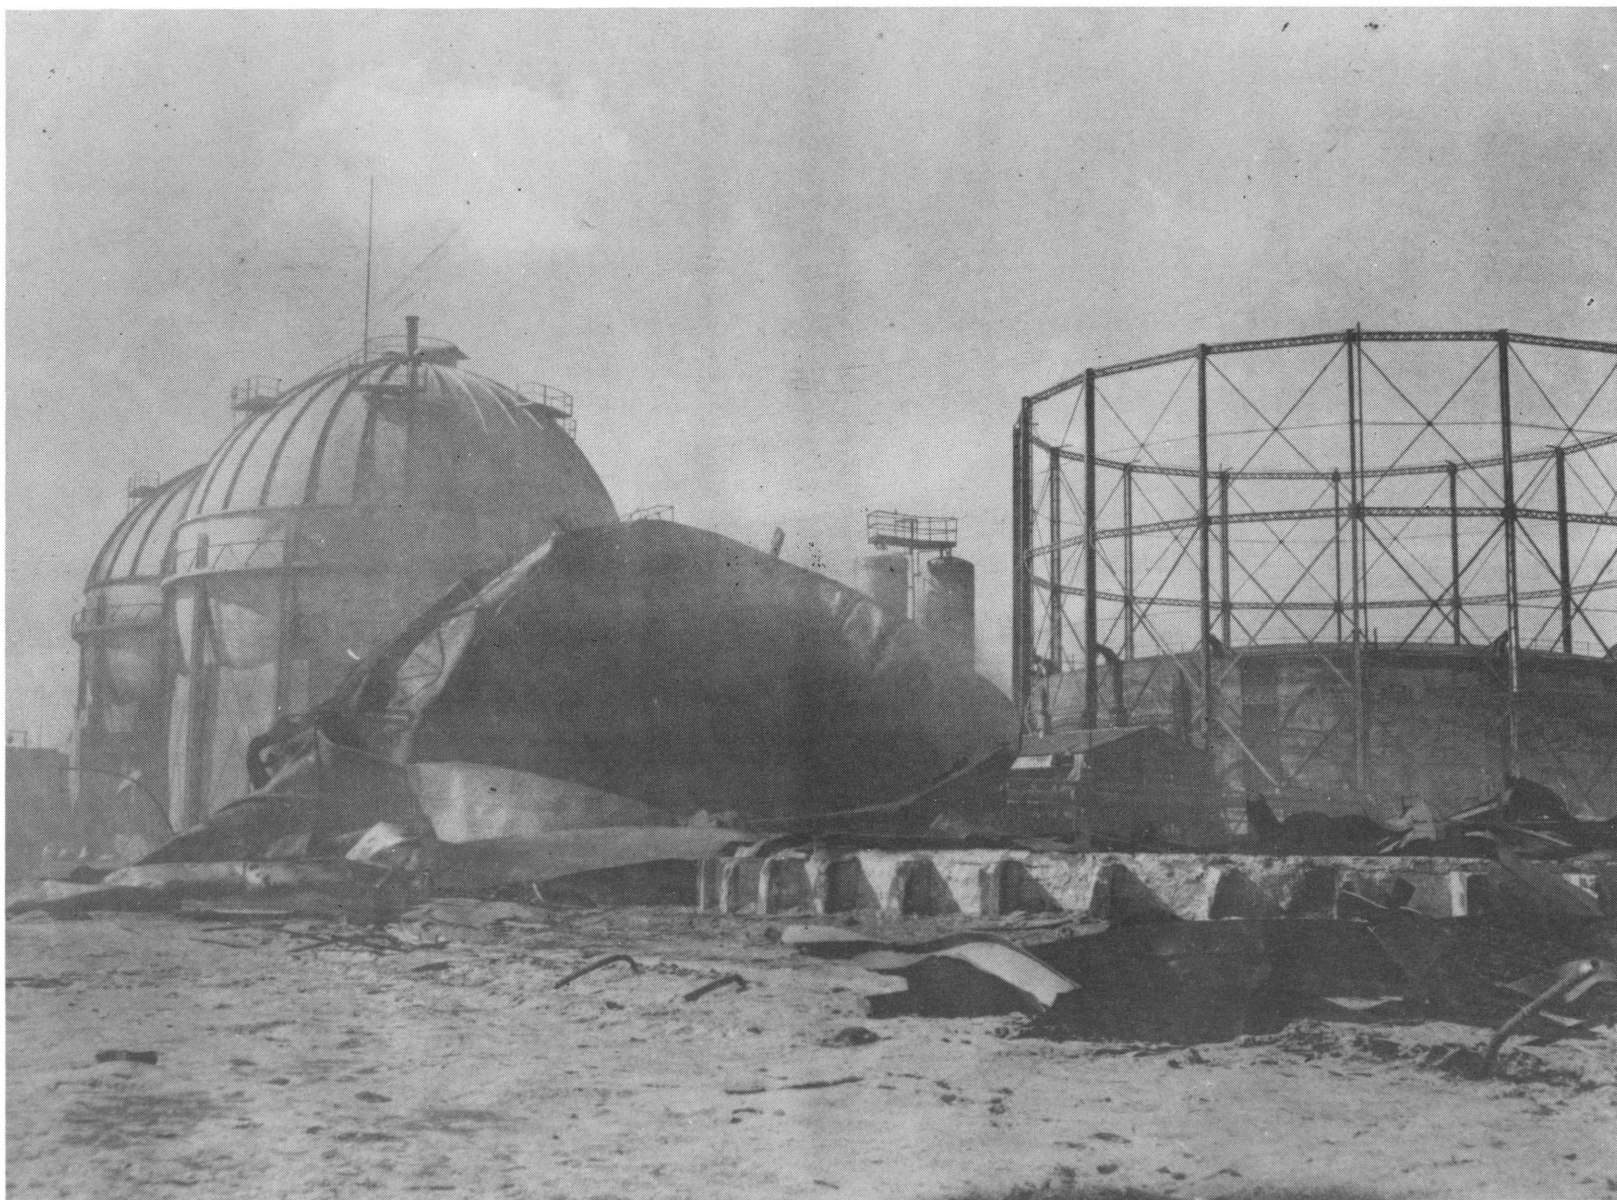
Figure 26.—Damage to LS & R plant, East Ohio Gas Co., looking west, showing foundation of tank 4 in the foreground and collapsed spherical tank 3.

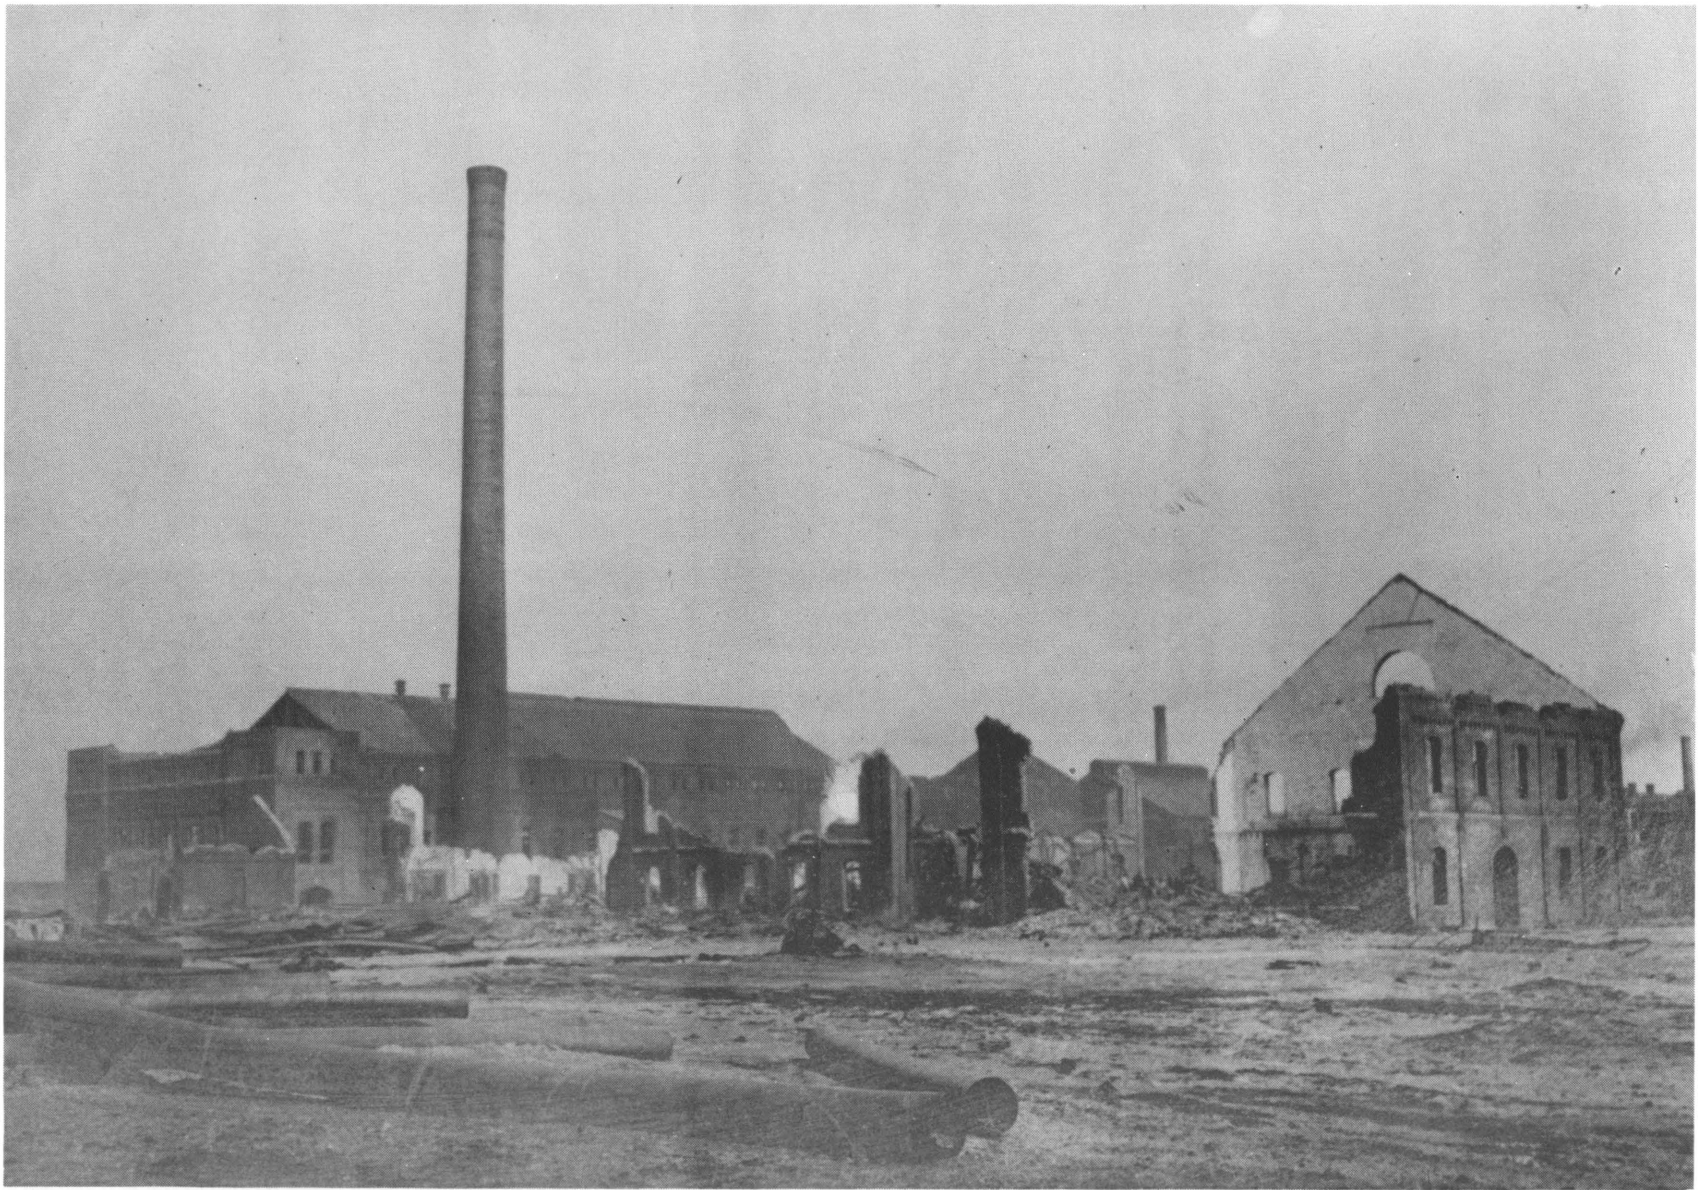
Figure 27.—Damage to No. 2 works, East Ohio Gas Co., adjacent to LS & R plant
(boiler house in background and remains of meter-repair shop and
offices in foreground).

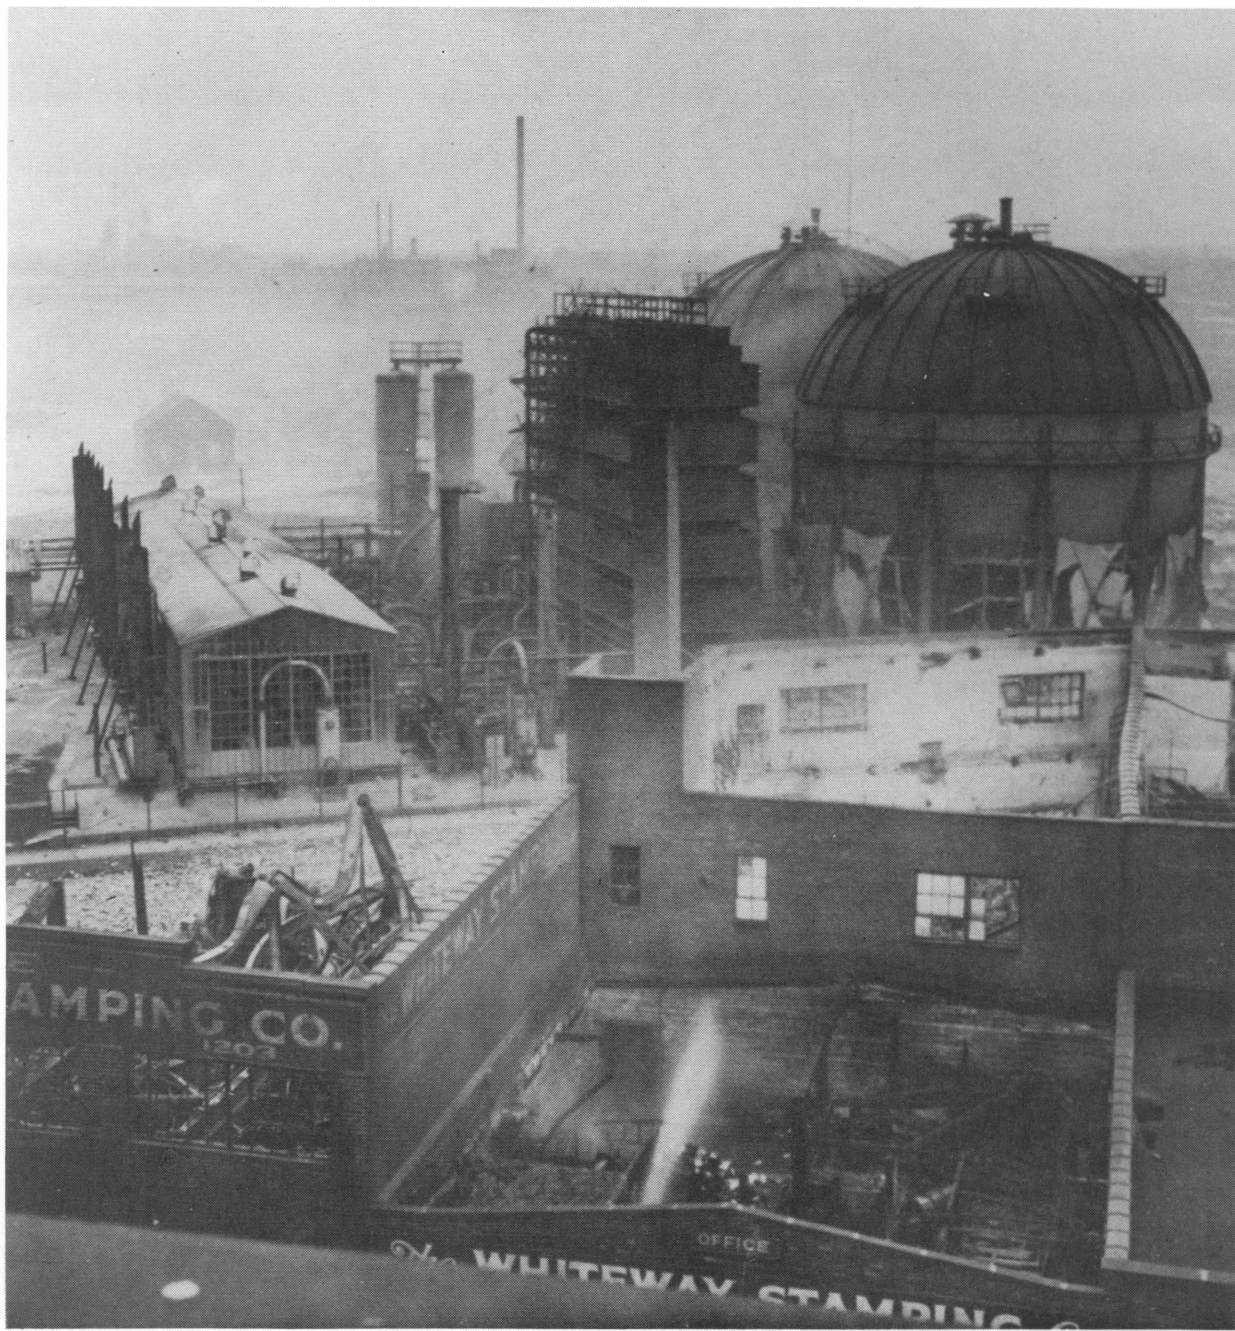
Figure 28.—General view of damage to LS & R plant, East Ohio Gas Co., looking east, showing spherical tanks 1 and 2 standing at the right and cooling tower with burned grids in the center and compressor building with broken window panes at left. Damaged building of the Whiteway Stamping Co., in foreground.

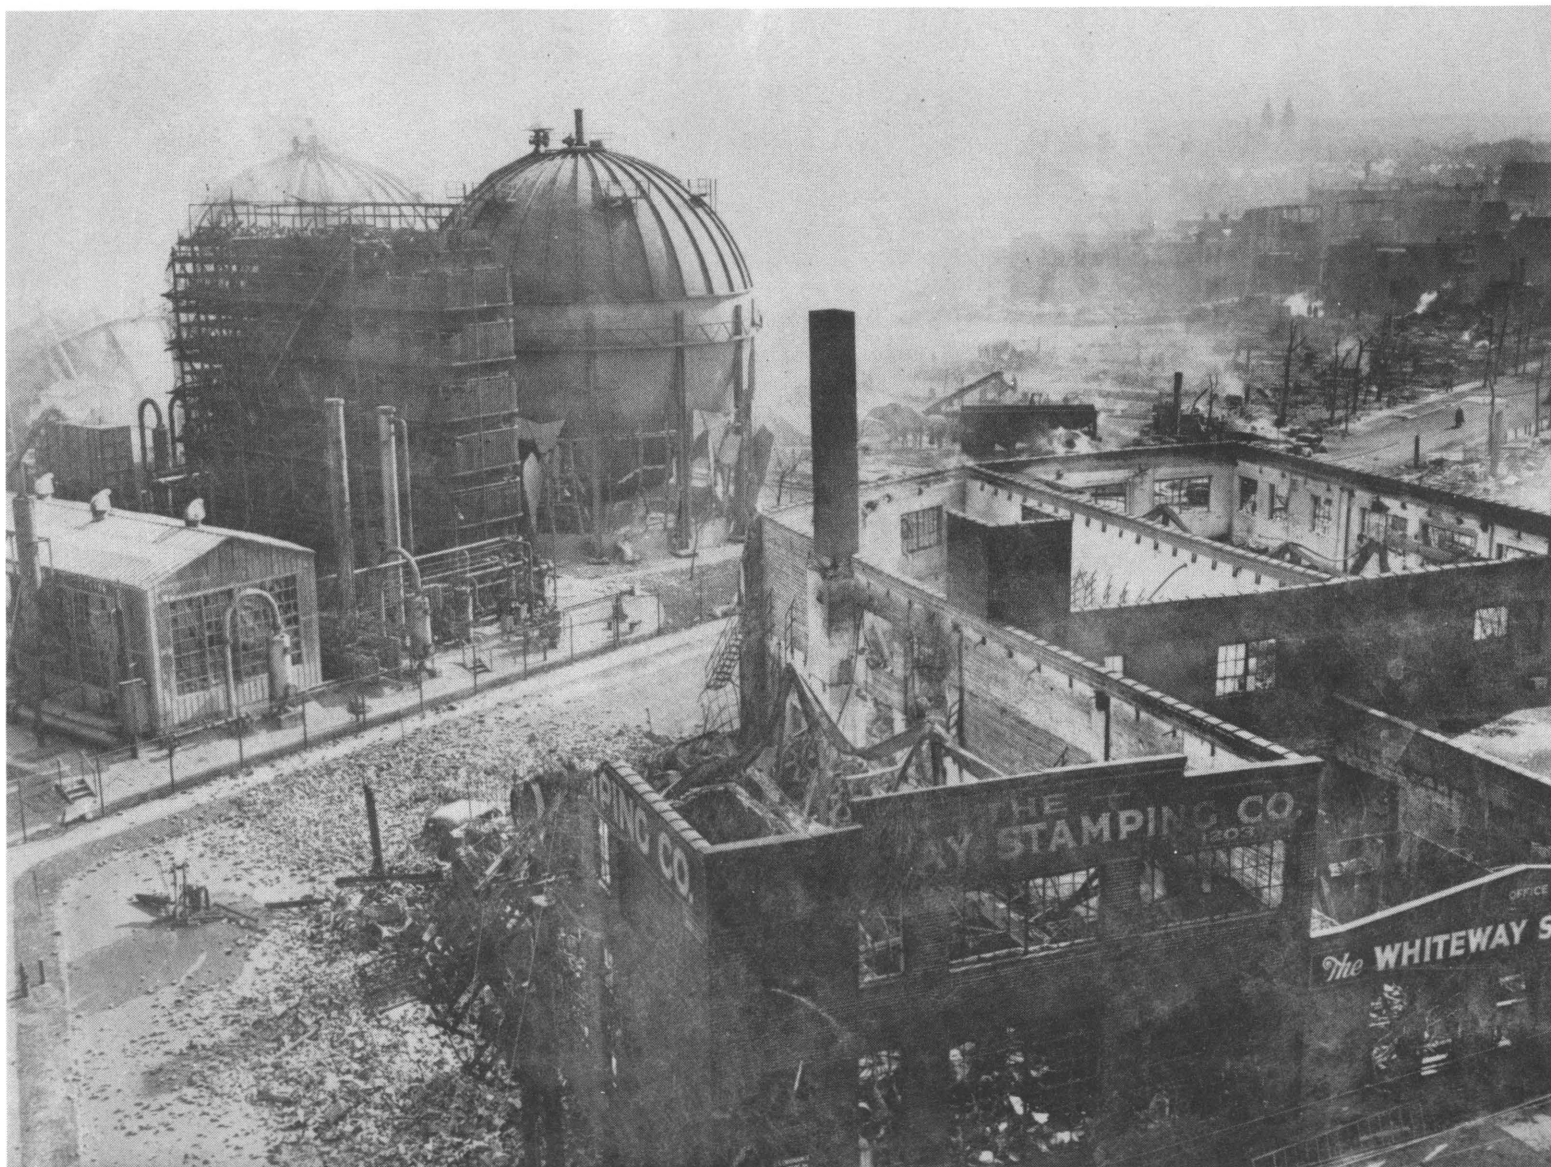
Figure 29.—View of damage in the vicinity of the LS & R plant, East Ohio Gas Co., looking east, and showing damage to the Whiteway Stamping Co. in the foreground, remains of dwellings on the east side of East 61st Street (right background), and spherical tanks 1 and 2, cooling tower, and compressor building of the LS & R plant (left background).

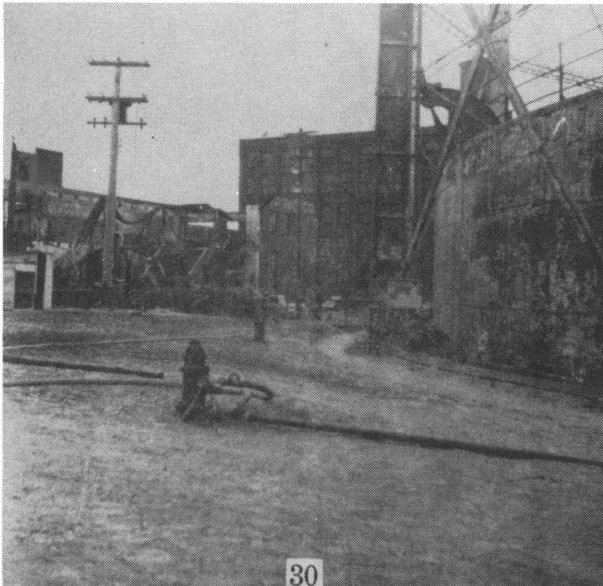
Figure 30.—Damage to east side of gas holder caused by heat from the fire.

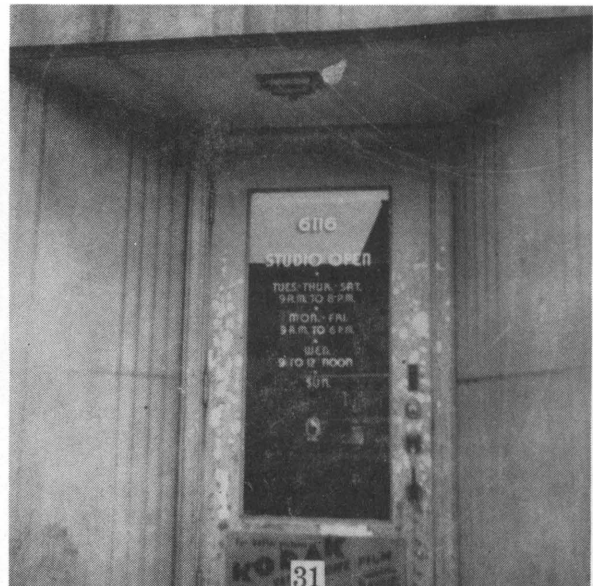
Figure 31.—Effect of radiant heat from the flames at a point approximately 1/4 mile away from tank 4

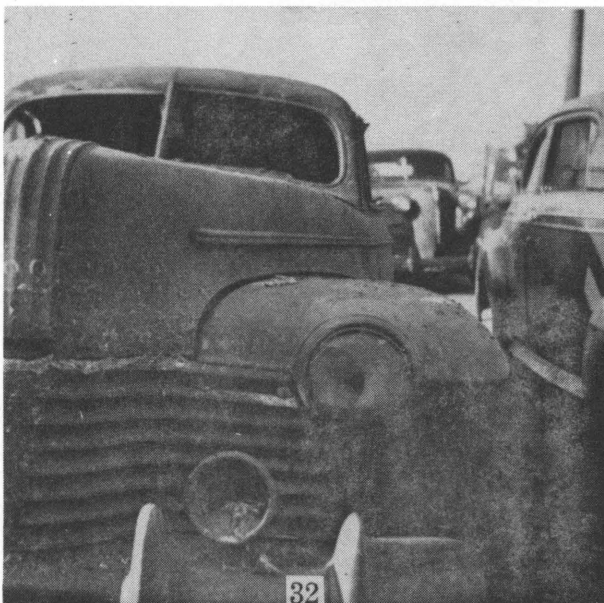
Figure 32.—Damage to an automobile parked on the west side of East 62d Street near the American Gas Association laboratory.

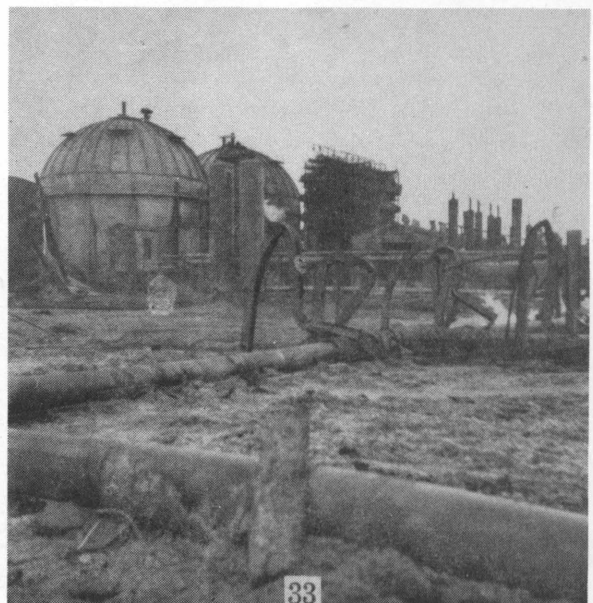
Figure 33.—Failure of steel-column supports for the steam line in the East Ohio Gas Co. plant.

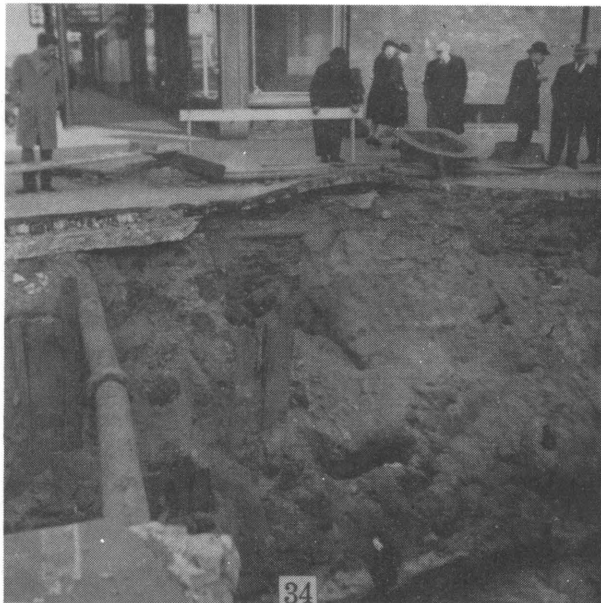
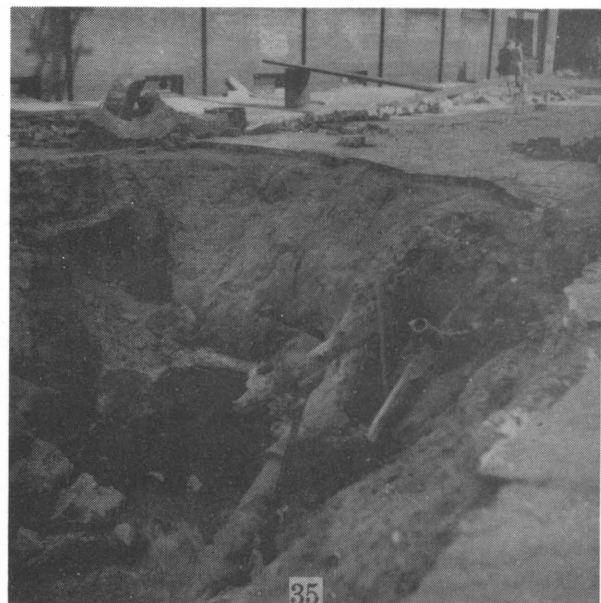
Figure 34.—Sewer at East 62d and St. Clair Streets in the process of being repaired.
 Figure 35.—Sewer at East 62d and St. Clair Streets.
 Figure 36.—East 62d Street, looking north.
 Figure 37.—East 62d Street, looking south.
