REPORT OF INVESTIGATIONS

REPORT ON THE INVESTIGATION OF THE FIRE AT THE LIQUEFACTION,
STORAGE, AND REGASIFICATION PLANT OF THE EAST OHIO
GAS CO., CLEVELAND, OHIO, OCTOBER 20, 1944

At approximately 2:40 p.m. on October 20, 1944, a disastrous fire occurred at the Liquefaction, Storage, and Regasification (LS&R) Plant of the East Ohio Gas Co., Cleveland, Ohio, as the result of failure of an insulated cylindrical tank in which liquefied natural gas was stored at less than 5 p.s.i. pressure and at a temperature of -250°F . Eye witnesses of the initial stages of the failure of the tank reported that streams of liquid or fog issued from its side, and that almost immediately the tank opened and discharged its entire contents of liquefied natural gas over the plant area and adjoining property at a lower elevation. The gas or vapor was ignited almost immediately after failure of the tank. Liquefied gas entered storm sewers, mixed with air, was ignited, and exploded. The explosions damaged the sewer system and the paving of some of the streets. The intense fire in the vicinity of the plant caused great loss of life and property. Final tabulation of fatalities by the coroner's office indicat

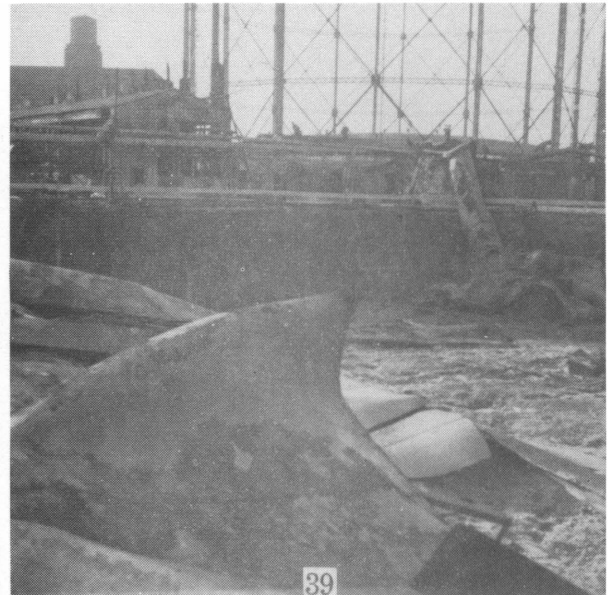
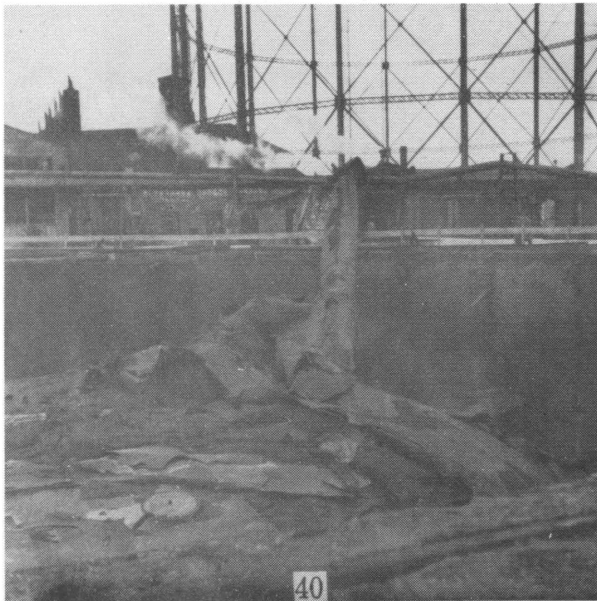
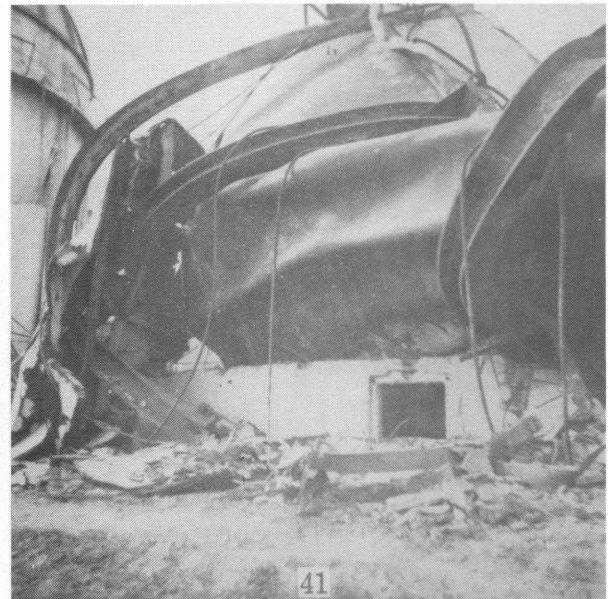
Figure 38.—Ducts leading to the dams of the three spherical tanks.
Figure 39.—Damage to top of overflow gas-storage tank.
Figure 40.—Damage to top of overflow gas-storage tank.
Figure 41.—Columns of spherical tank 3 bent by heat from the fire.

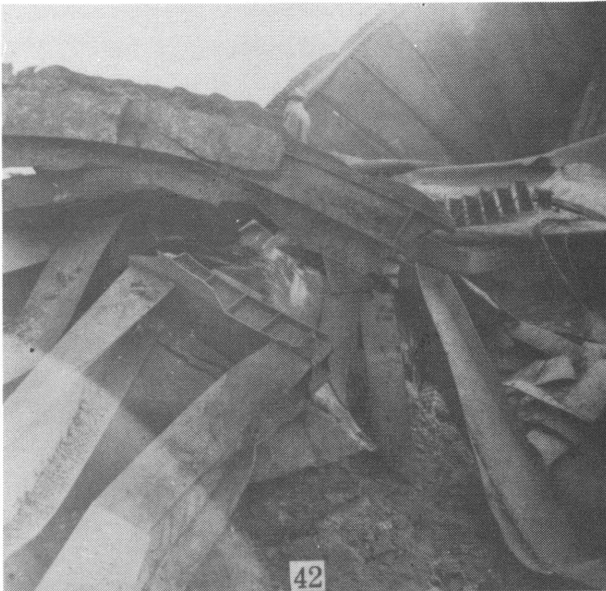
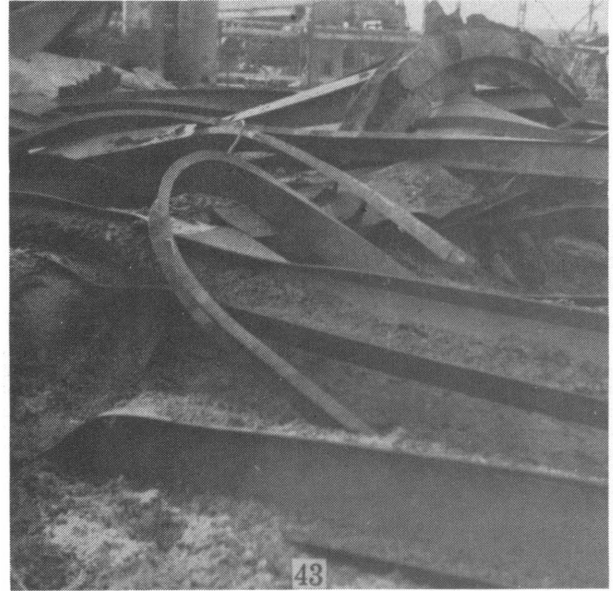
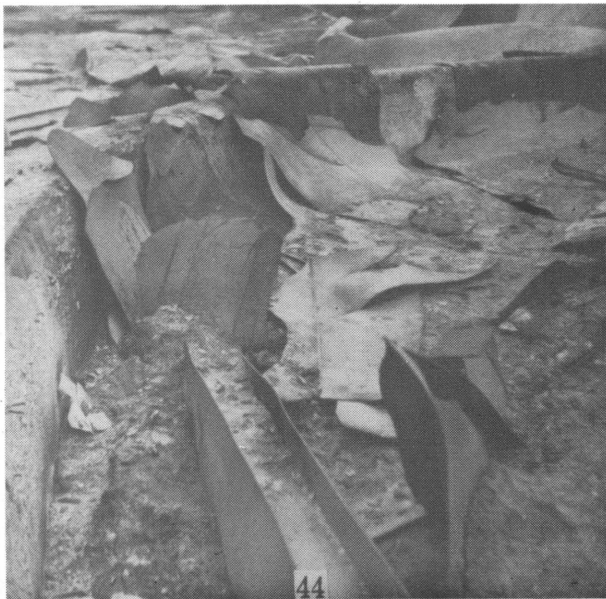
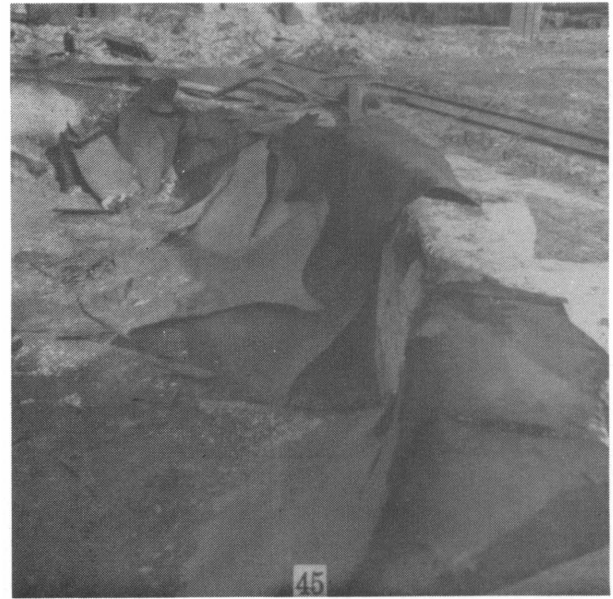
- Figure 42.—Portions of the circular girder to which the interior columns were attached.
- Figure 43.—Interior columns of tank 4, showing typical embrittlement fractures and deposit of rock-wool insulation.
- Figure 44.—Plates in outer ring-shaped footing of tank 4 showing typical embrittlement fractures.
- Figure 45.—Plates in outer ring-shaped footing of tank 4 showing typical embrittlement fractures.
