MINISTRY OF HOUSING
AND LOCAL GOVERNMENT

REPORT OF THE INQUIRY INTO THE

Collapse of Flats at Ronan Point, Canning Town

Presented to the
Minister of Housing and Local Government by
Mr Hugh Griffiths, QC,
Professor Sir Alfred Pugsley, OBE, FRS, MICE, M I STRUCT E,
Professor Sir Owen Saunders, FRS, HON M I MECH E, F I N S T E

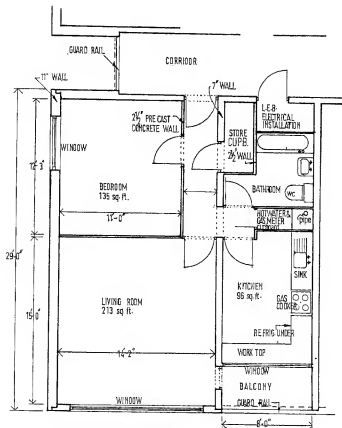
Plan (b) Layout of Flat 90

63. The general nature of the damage and disturbance to the contents of the flat pointed to a region of greatest explosive effect in the hall of the flat near the door of the store cupboard, with a lesser degree of effect in the kitchen and elsewhere. By examining the displacement of articles in the flat and the nature of the damage which they suffered it was possible to trace the pressure wave as it propagated throughout the flat. It was evidence of this nature that finally disposed of a theory put forward during the earlier stages of the inquiry that the explosion had originated within the hall store cupboard. An examination of the damaged hinges of the cupboard door and their screws and also the wood nails attaching the door frame to the wall showed clearly that they had all been bent in a manner which was only consistent with the door being blown inwards into the cupboard and not outwards, as would have been the case had the explosion occurred in the cupboard.

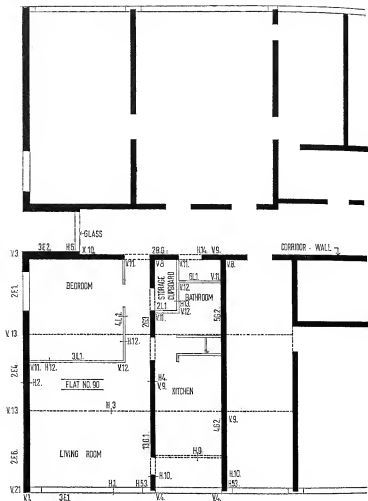
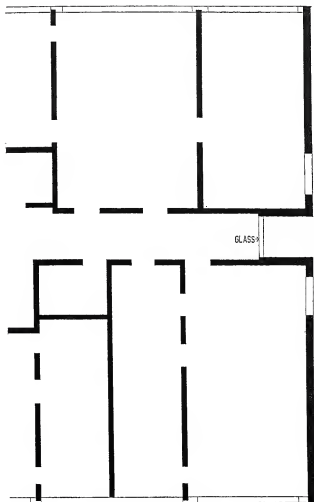
Figure B Arrangement of structural walls in Roman Point

101. The tower-like structure of Ronan Point rests upon a heavy reinforced concrete podium, which in turn is supported by numerous large diameter piles. We are concerned primarily with the tower structure above the podium. This consists essentially of a number of load-bearing vertical walls arranged in plan as shown in Figure B. The structure is approximately symmetrical about the 'spine' walls bounding the main corridor, and comprises, in addition to these corridor walls, a number of 'cross' walls at right angles to them, together with 'flank' walls forming the end faces of the tower block. All these walls are load-bearing; the cross walls are firmly connected to the corridor walls, but the flank walls have no such structural connection. The floors within the tower block, except for the corridor floors, span between the flank and cross walls and rest at their ends upon them. The corridor floors span similarly between the corridor walls. The structure of the flat roof, save for the parapet walls, is broadly similar to that of a floor below.

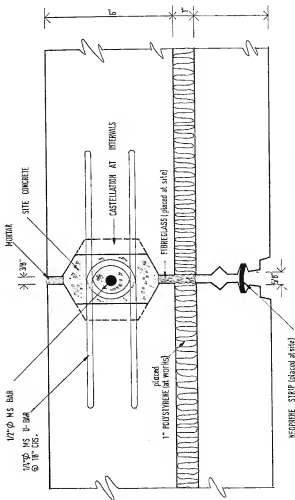
Figure C Joint V.13. Vertical joint between adjoining wall panels

104. The jointing between walls and floor panels is fundamental to the integrity of the structure; without adequate connections it will be realised that the structure is essentially just like a tower built from a pack of stiff cards. There are four kinds of joint of special importance that are in use throughout the tower structure. These are illustrated in section by Figures C, D, E and F. The vertical joints between the adjoining wall panels are all essentially as illustrated in Figure C; it will be seen that projecting from the castellated sides of the panels, are overlapping U-shaped steel rods through which a vertical steel rod is threaded. The whole joint is then concreted in-situ. The horizontal joints between floor slabs are as shown in Figure E; the 'wine-glass' shaped space between adjoining slabs is filled with in-situ concrete into which a short steel rod is placed over the supports.

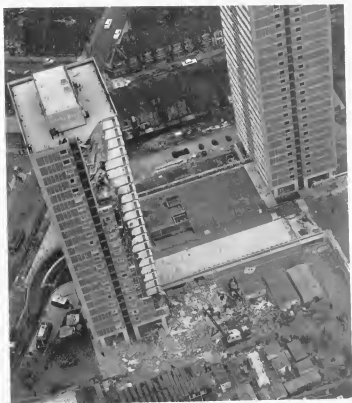
Plate No 1 *Aerial view showing Ronan Point and Merritt Point*

39. Ronan Point was the second of the nine identical blocks to be completed. It comprises 22 floors of flats built in the Larsen Nielsen system resting on an insitu concrete podium containing garages and a car deck. The overall dimensions of the block are 80 feet by 60 feet, and it is 210 feet high. (See Plate No. 1). There are five flats on each floor, each comprising a living-room, kitchen and bathroom, with 2 bedrooms each in two of the flats on each floor, and 1 bedroom in each of the other three flats, giving a total for the block of 44 2-bedroom flats and 66 1-bedroom flats. Access to all flats on each floor is from a central corridor served by two lifts and a staircase (see Plan (a)). There is a refuse chute serving all floors. All bathrooms are internal, and are ventilated by ducts with extractor fans at roof level. Electricity and gas are laid on to each flat.
