The Texas City Disaster.

A Staff Report.*

Four hundred and sixty-eight persons are known to have lost their lives, over a hundred are still missing (July 1, 1947), and 3000 were injured as the result of fires and ammonium nitrate explosions aboard two ships docked at Texas City, Texas, April 16-17, 1947. Property damage and contingent losses are estimated at \$67,000,000.

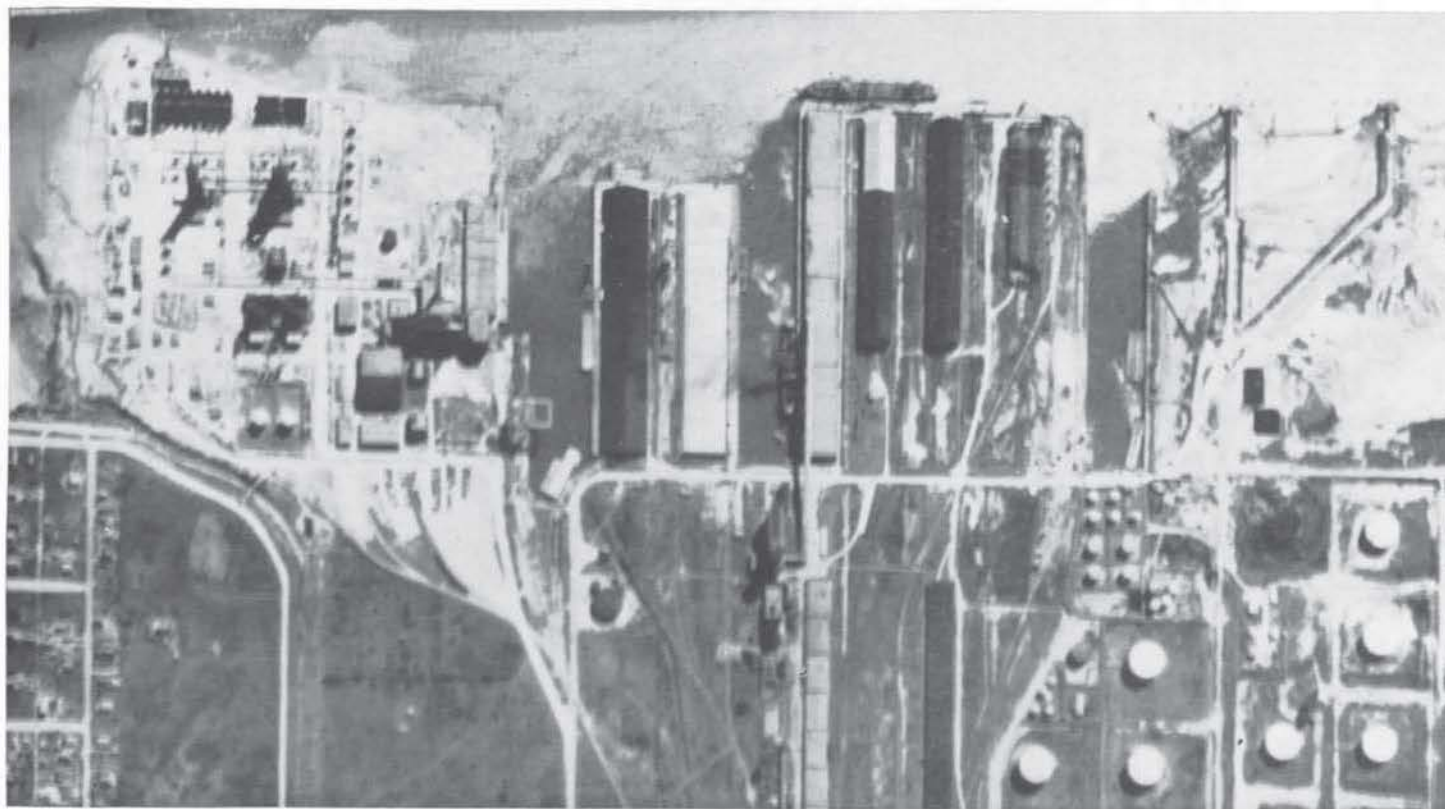
Vertical photograph of Terminal before the explosion. Monsanto plant at left, with South Slip (where *Grandcamp* was berthed) adjacent. The *High Flyer* was in the Main (center) slip adjacent to the longest fire-resistive warehouse. Note relation to oil tank farms at lower right.

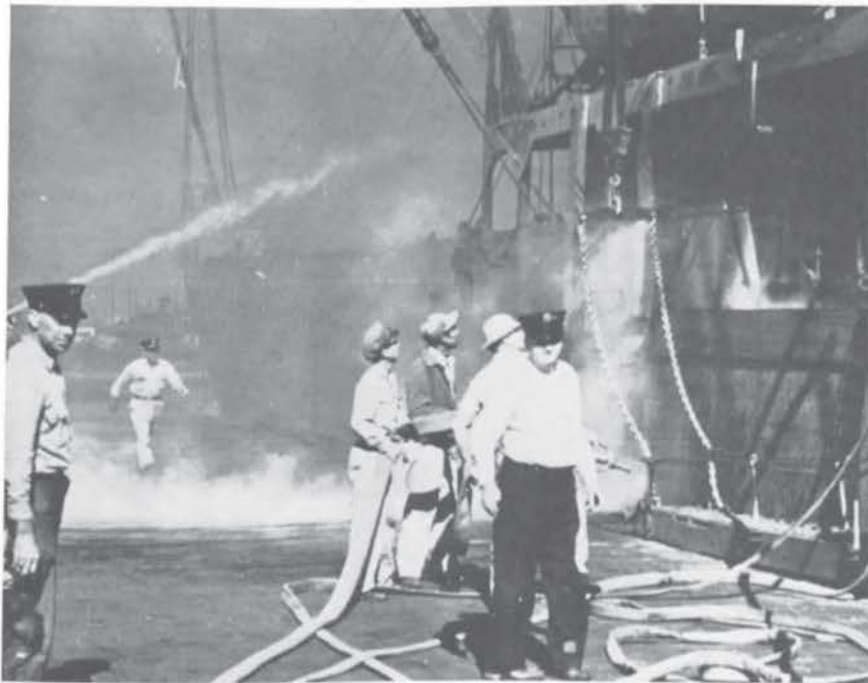
Texas City firemen fighting the fire aboard the *Grandcamp* prior to the explosion. Note one hose line in service, others being prepared. All 27 firemen who responded were killed by the blast.

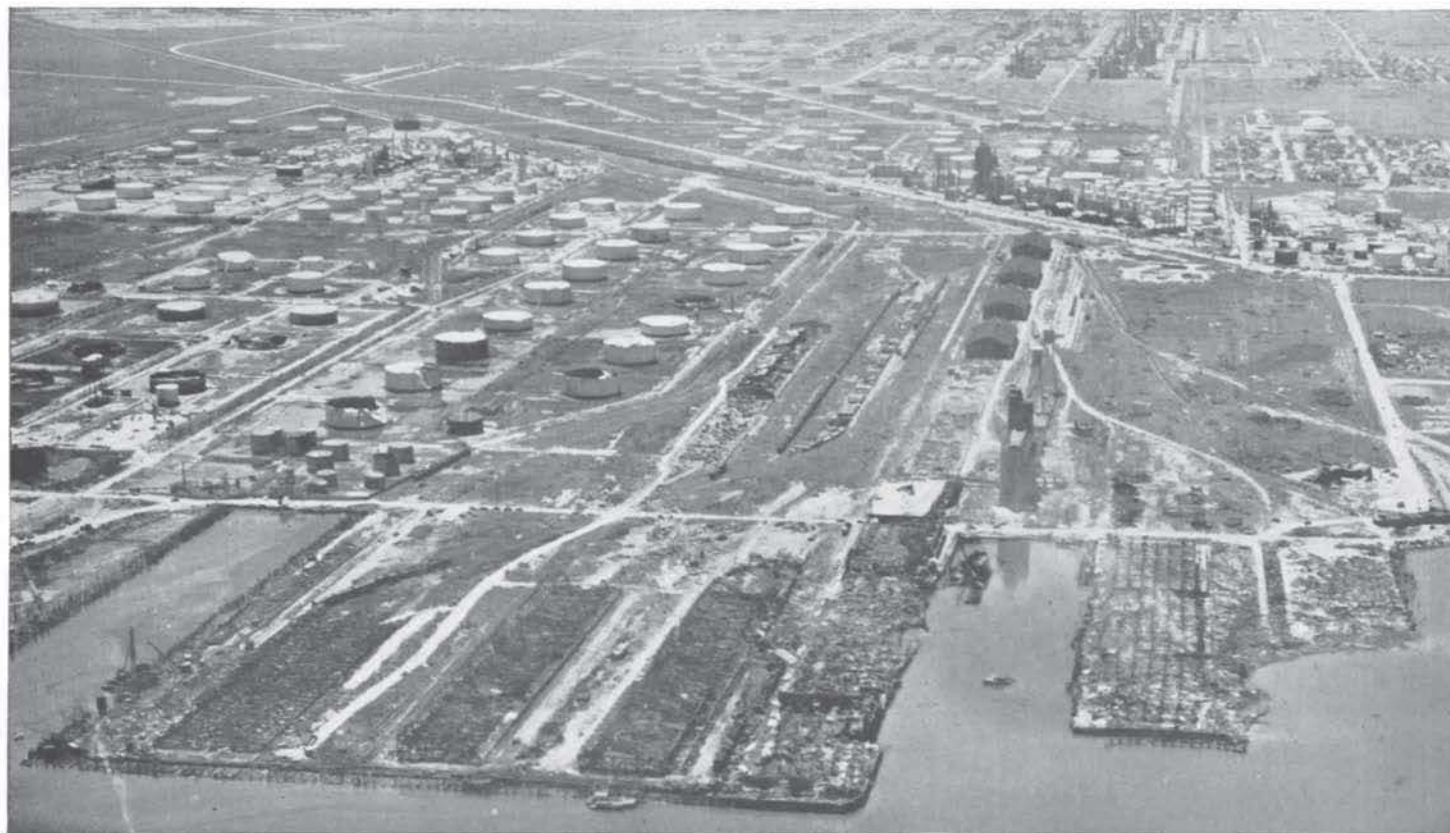
Concussion forces were again severe. Reinforced concrete Warehouses A and B were reduced to rubble, except a small portion of Warehouse B on the shore end, which remained standing. Warehouses C, D, and E (unprotected steel) were collapsed further, original damage having been from fires started by the *Grandcamp* explosion and from exposure to the oil fires burning along the water front. A structural steel grain conveyor which connected the reinforced concrete grain elevator with Warehouse B (over the roof) was collapsed. Other buildings in the Terminal area, damaged by the first explosion, were demolished by the second.

View of Texas City Railroad Terminal property from an altitude of 5000 ft., taken two weeks after the disaster. (See other similar photos of oil tank farm areas and the Monsanto Plant.)

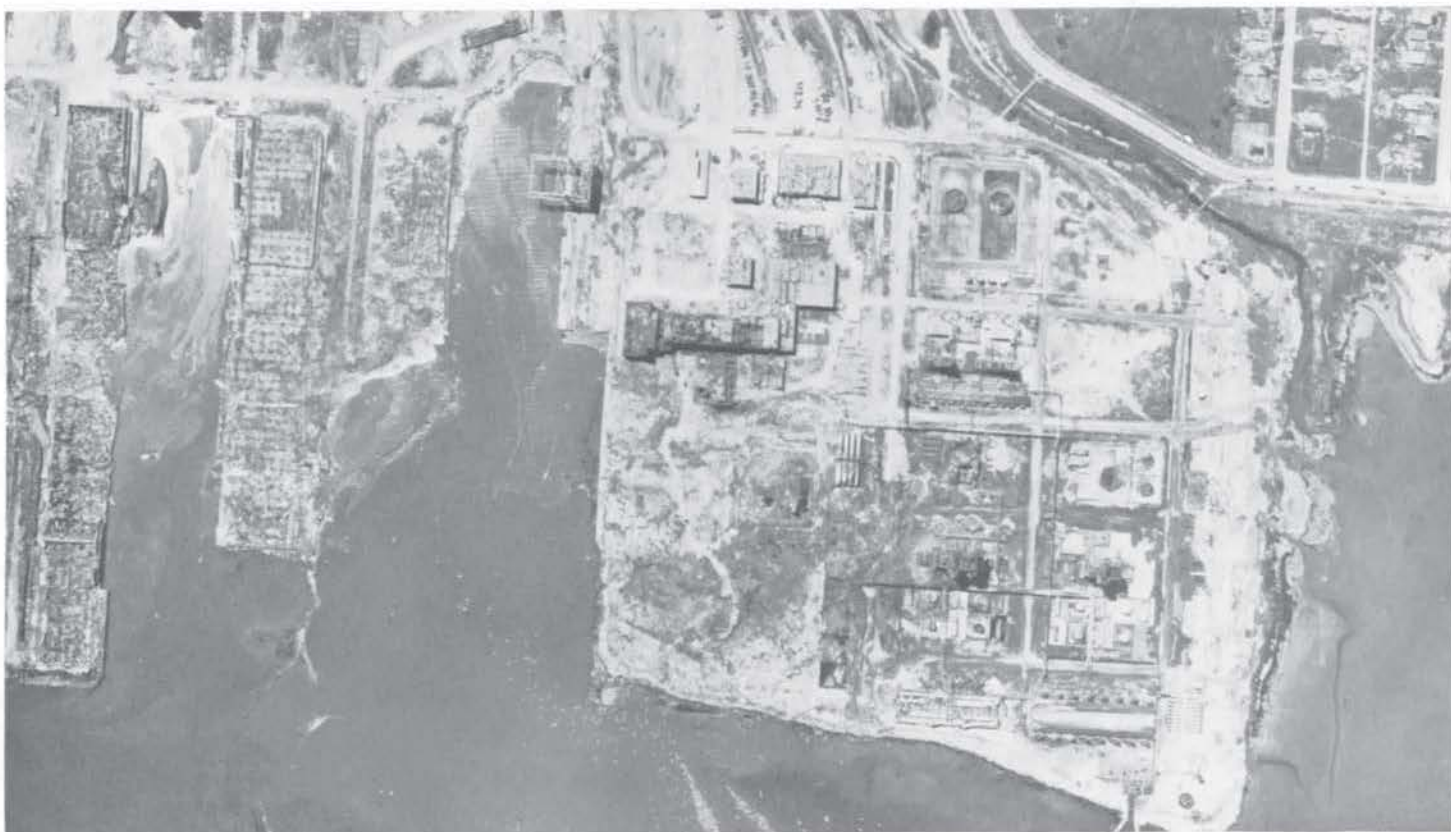
Vertical photograph of the Monsanto plant and adjoining Terminal property two weeks after the explosion. This picture and other U. S. Army Air Forces photographs were taken to study the concussion damage effects and to compare them with bomb damage inflicted in Europe and Japan during World War II.

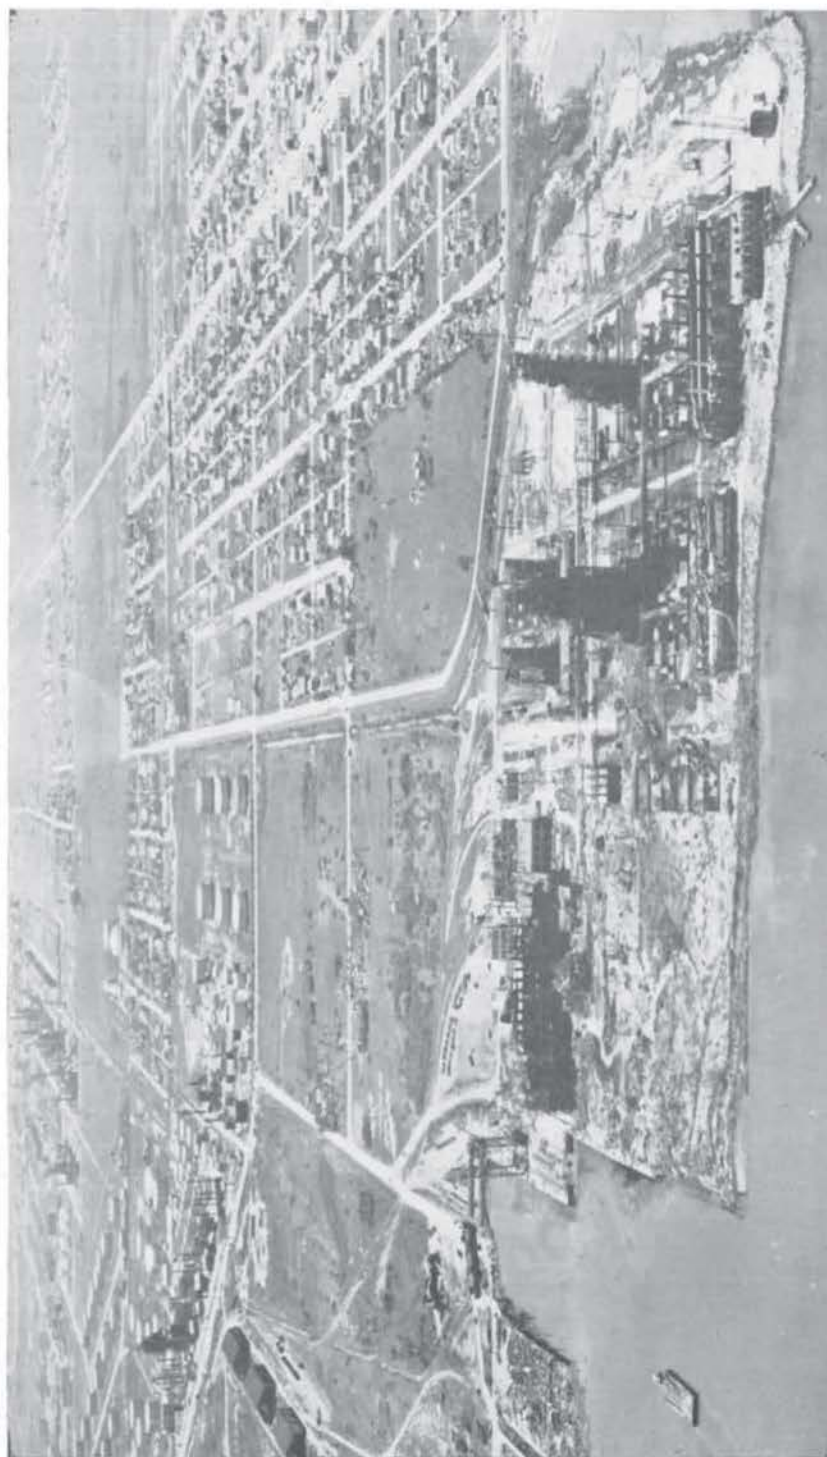
The fires occasioned by this initial blast are best portrayed photographically. The Monsanto plant was literally engulfed in flames. In the main, these fires were caused by the ignition of combustible hydrocarbons, especially in the polystyrene building, the ethylene purification units, the process equipment and control facilities of the alkylation unit, the distillation towers and the fourteen main storage tanks of benzol, fuel oil, and other low vapor pressure hydrocarbons. Ground fires spread fire damage to piping and were fed by flammable liquids which escaped from broken or melted lines. The fact that the highest pressure on equipment in the plant was around 15 pounds was a factor which must be credited, at least partially, with the fact that there were no separate explosions in the Monsanto plant area.

Aerial view of the Monsanto plant two weeks after the disaster. The *Grandcamp* exploded in the slip at the left. (See other similar photos of the Terminal and oil tank farm areas.)

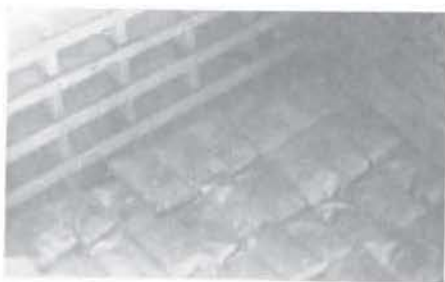
3. The multi-walled paper bags were so constructed that the second sheets from the outside and inside were impregnated with an asphaltic material to provide moisture resistance. This material would increase the heat of combustion.

4. The labeling on the bags gave no indication that the material was hazardous and did not conform strictly to regulations in that the name "Fertilizer" preceded the designation "Ammonium Nitrate," instead of vice versa.

Stowage of ammonium nitrate fertilizer in ship's hold, showing cargo battens.
